## SOME ERGONOMIC ISSUES OF DP VESSEL CONTROLS

M Hadfield, Health and Safety Executive, UK

### SUMMARY

A number of loss of position incidents have occurred due to accidental, unintentional, transfer of control from DP to manual. The incidents can be attributed largely to poor ergonomic design of the DP control systems.

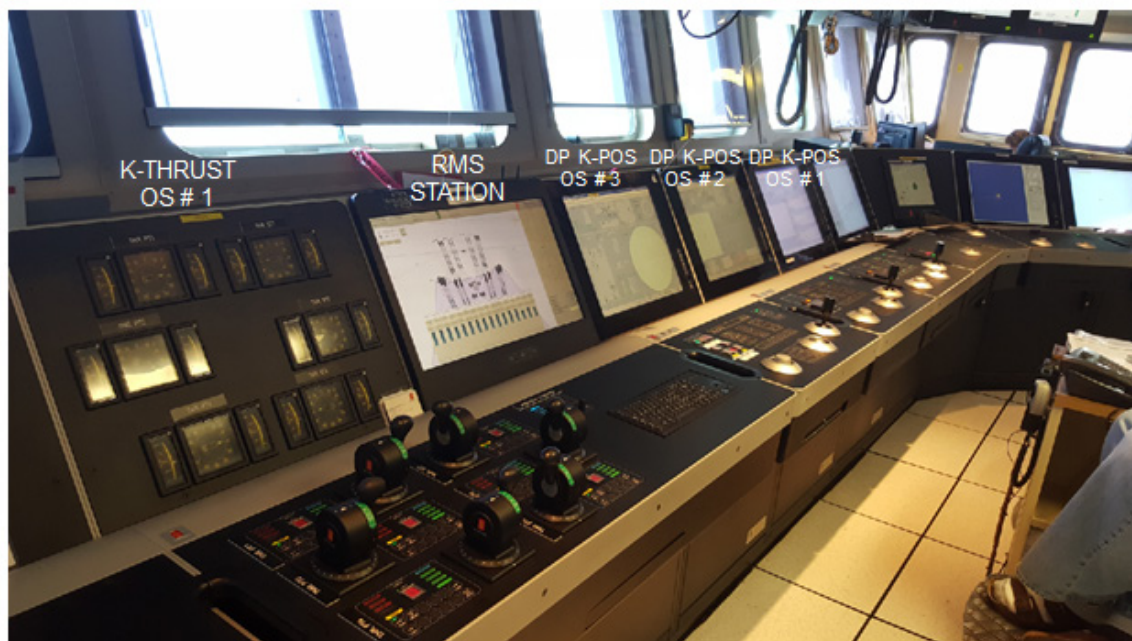
There was no clear indication at the DP control desk that DP was disengaged and the vessel was now under manual control. The desk in use was the middle desk – OS#2 in Fig1.

Figure 1: Bridge View showing manual lever control desk, RMS riser management desk, and three DP control desks.

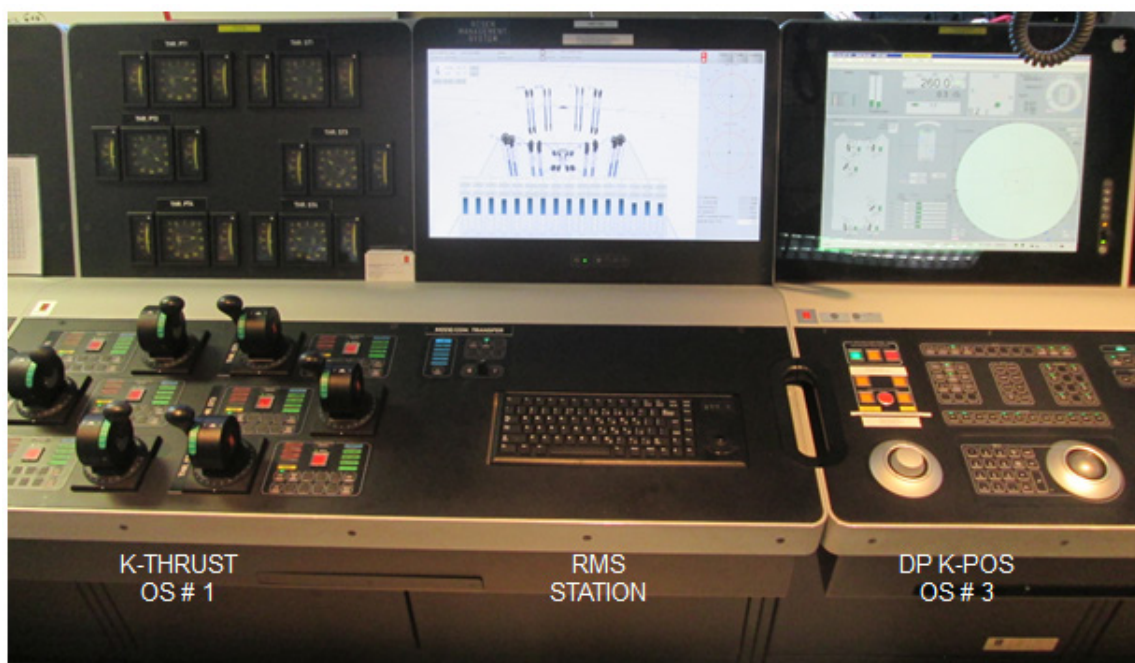
The buttons to select mode of control are in a small utility panel on the riser management desk which was two desks to the operator's left. Fig 3 shows the DP selector button illuminated to show DP is selected. The adjacent button would select manual lever control, and that button would then be illuminated.

The most obvious indication would have been the light on the lever manual button on the utility panel which would have become lit rather than the adjacent DP button. However, that is not actually very obvious being some distance from the then operational DP desk and (it is believed) both lights were the same colour.

Figure 2: Close up of manual lever desk, riser management desk, and one DP desk. The utility panel is top left on the riser management desk

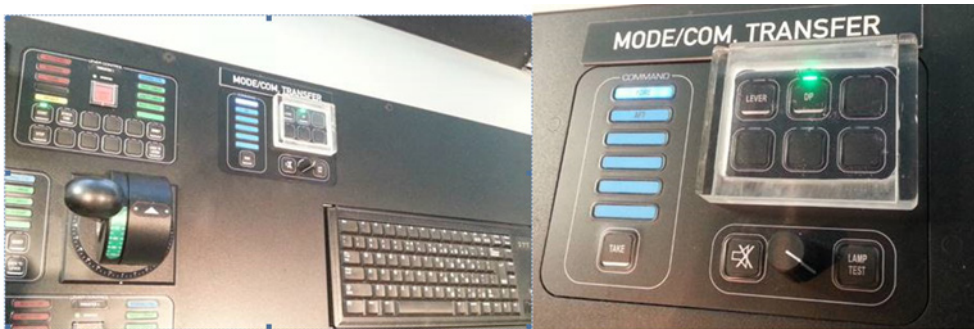
The only protection against accidental activation was a double push requirement on the button. This required two pushes within 2 seconds.

The investigation found that it was likely that the manual button had been accidentally activated when someone was working at the Riser Management desk. It might have been leant on or notes might have been taken above the button. Possibly papers or documents needed for this work had been placed on top of the button. It is recognised bad practice to place anything onto DP desks in this manner. However, the equipment designers do not seem to have provided a suitable place for such papers.

Figure 3: Close ups of (left) a manual lever control and the riser management desk, and (right) the utility panel with a protective Perspex cover fitted after the incident.

Soon after the incident, a cover guard was fitted to the utility panel as shown in Fig 3.
