Severe Accident in Fukushima Dai-ichi Nuclear Power Plant and Lessons-Learned

October 14th , 2015

Akira Yamaguchi
University of Tokyo, JAPAN
E-mail: yamaguchi@n.t.u-tokyo.ac.jp

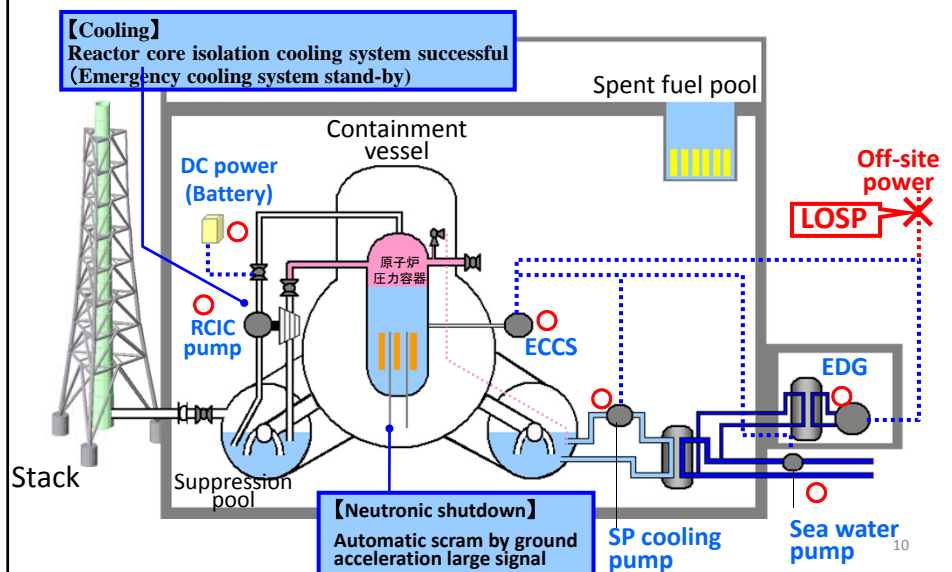
After Earthquake: Safety Functions Successful
March 11, 14:47pm

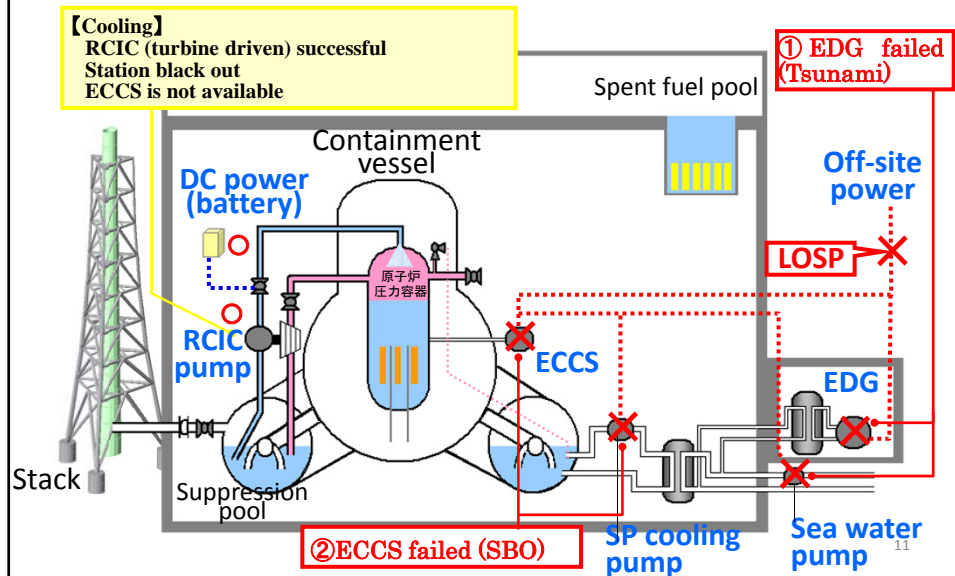
After Tsunami: SBO and Loss-of-Ultimate-Heat-Sink at 15:37

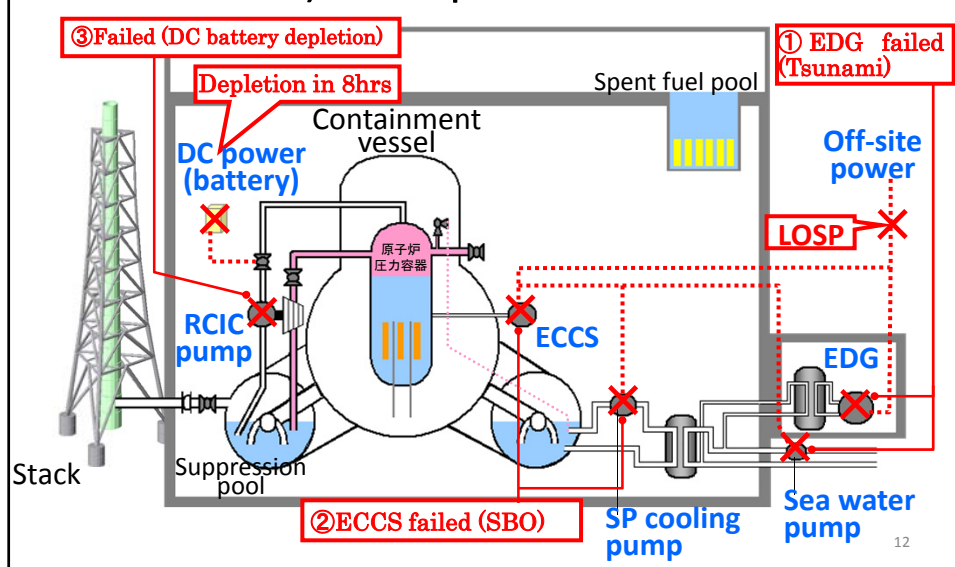
After DC Battery Depletion (8 hours at least): It Depends on Units

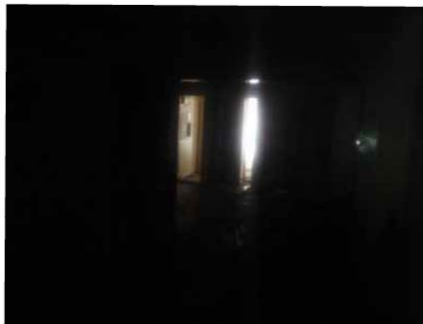
<Working in the darkness>

Taken the Service Building entrance from the inside.
The floor was cluttered with objects.

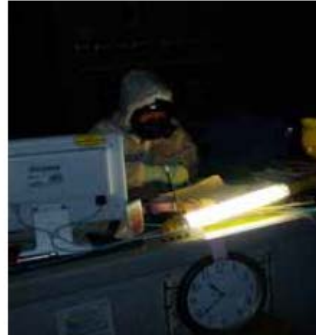
Monitored by the Assistant Shift Supervisor

The Assistant Shift Supervisor at the desk monitored plant data and information wearing a full face mask in the total darkness.

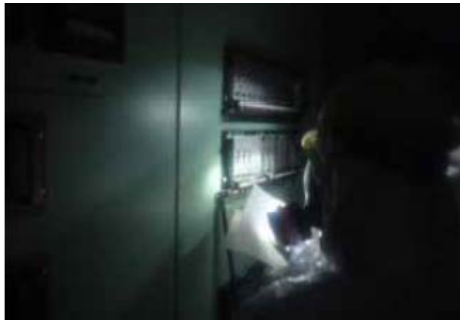
Checking Instrument Gauges

Checking instrument gauges in the total darkness with only a flashlight to depend on.

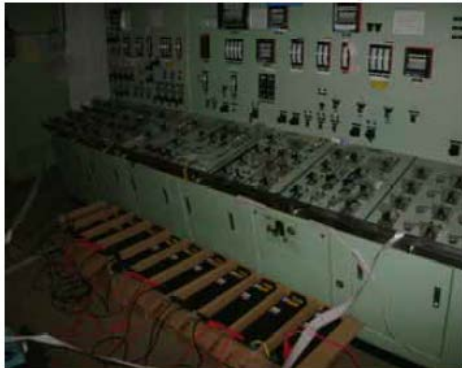
Temporary Instrument Power

Temporary batteries were connected to power control room instruments due to loss of power.

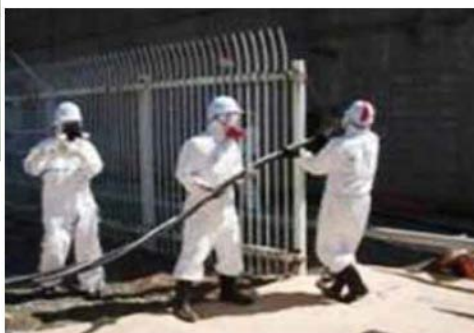
Installing Temporary Power

Workers who are not working for electrical system were called out to manually lay the power cables

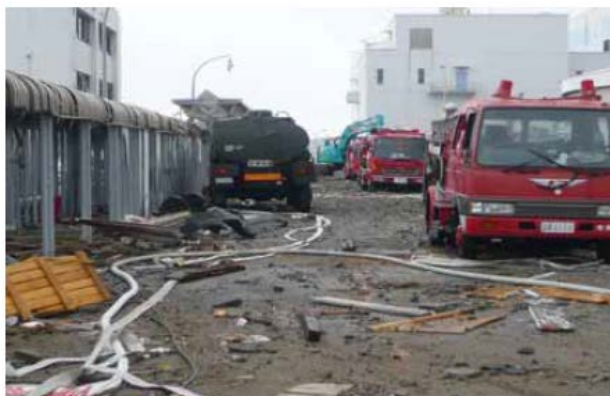
Obstacles on access routes

Fire hoses caused detour for access. After the explosion, debris and damaged fire engines become additional obstacles.

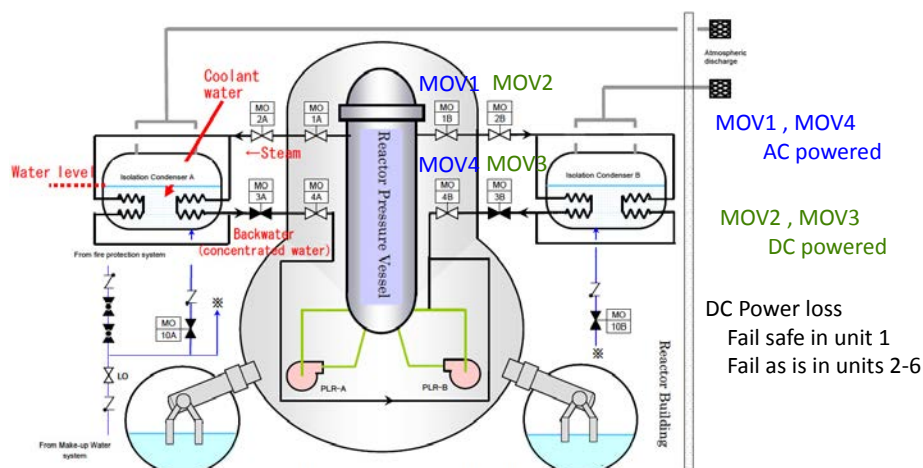
Figure 1 : System configuration of Isolation Condenser

Operators stopped B-system, controlled A-System

- Operator stopped IC because temperature decreases too fast (55C/h) which observes the procedures.
- IC valves are fail-safe (closed) while RCIC in other units isolation valves are fail-as-is for LOCA or loss of DC power. IC is used in Unit 1 only (CV function concept).
- DC power loss results in CV isolation in unit 1 while fail as is in SBO situation.
- DC power is lost earlier than AC power. Then the valves closed first and AC power loss followed.
- Valves inside containment are AC powered. Then, the recovery open is difficult.

- No IC operation status alarm (probably because of SBO). MCR lost lights at the same time and operators did not identify valve status indicator. Then the MCR did not notice IC valves closed and operation stopped.
- The operator closed MOV-3A manually but the fact was not shared in the MCR and HQ. The operation was almost at the same time as the Tsunami attack. No time to report and MCR was in absolute chaos.
- Because of aftershocks and tsunami alarms, no other batteries, electrical panel water-sprayed, early recovery of MOV-3A is difficult even if other valves are open.
- However early alternative water injection may be possible using DG-driven fire pump if IC status was known.
- No experience of IC operation in Unit 1. The plant simulator does not model the IC and the operators are not familiar with the system.
