B737 MAX: Lessons Learned from Tragedy

Katherine Wilson, PhD
National Transportation Safety Board
Washington, DC

Lion Air Flight 610

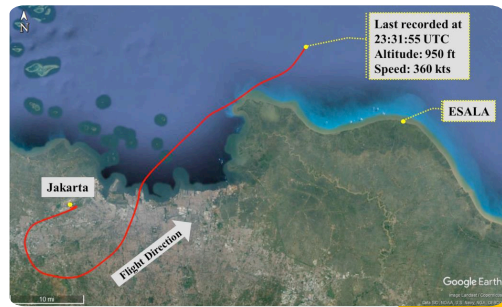
- Captain was pilot flying, First Officer (FO) was pilot monitoring
- FDR data showed
 - 21° angle of attack (AOA) disagree on takeoff roll
 - Stick shaker activation when nose wheel off ground
 - Airspeed (IAS) and altitude (ALT) disagree messages
- Flight crew reported a “flight control problem” to ATC
- Flight crew did not declare an emergency or request a return to departure airport

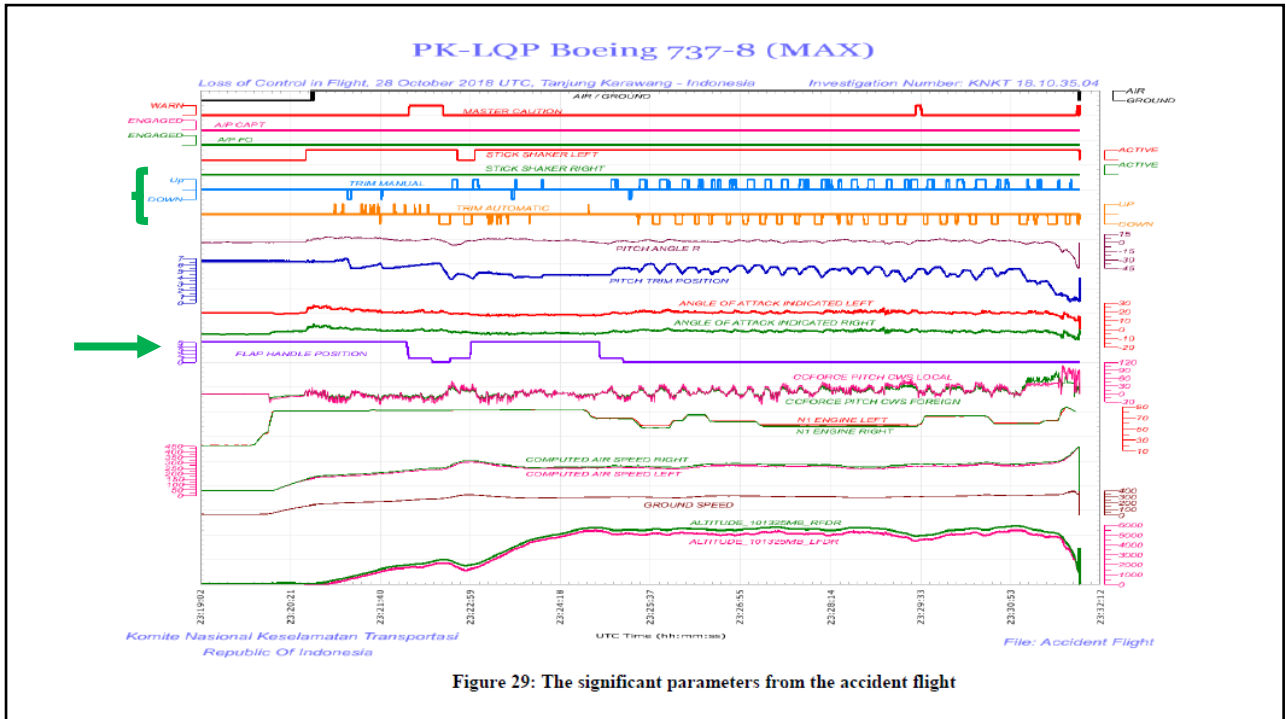
Figure 29: The significant parameters from the accident flight

- Crew raised flaps to “clean up” airplane after takeoff
- Activation of unintended/automatic nose down trim inputs
 - Nose down trim inputs activated a total of 24 times
 - Crew countered nose down trim with nose up trim
- Captain transferred control to FO about 54 seconds before crash
 - Shorter/less nose up trim inputs after transfer of control
 - Control column force increased up to 103 lbs. (46 kg)
