Marine Casualties Investigative Body

COSTA CONCORDIA

Marine casualty on January 13, 2012

Report on the safety technical investigation

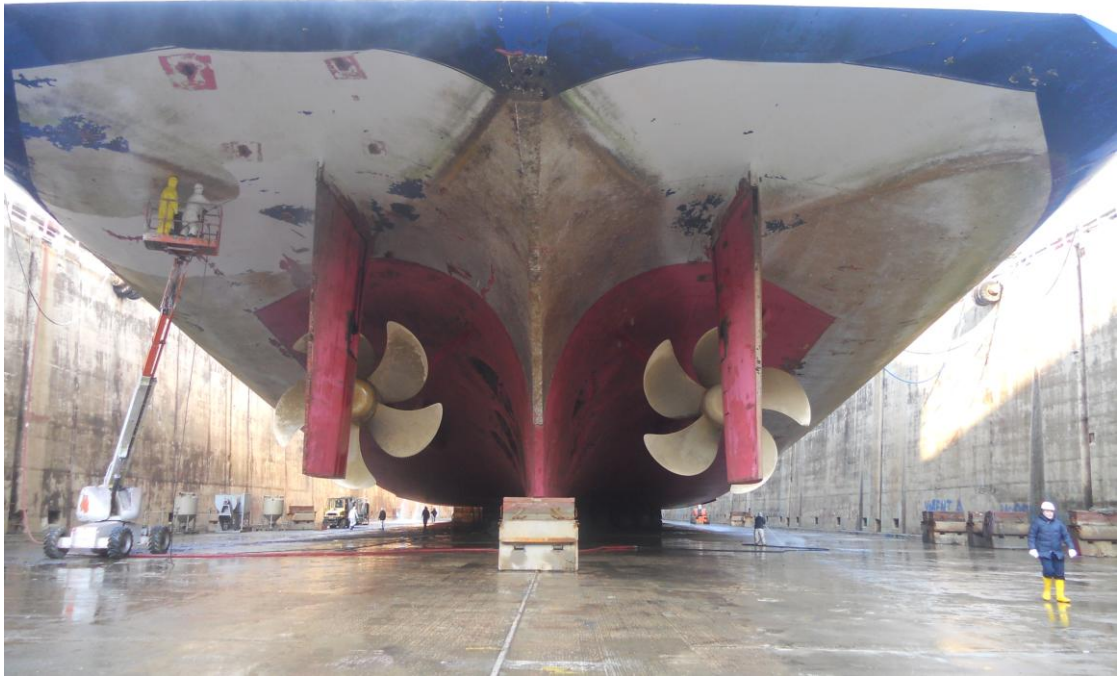
Following pictures show the hull area interested by the contact (taken from sister ship Costa Serena):

The hole on the left side upon impact, it is continuous for about 60 meters (about frames 52 to 124) located too far above the deck of the Double Bottom (so well over two meters from keel line). This was crucial in terms of severity of the accident, because rather than be hit the bottom of the ship, if the more defence due to the double hull, was vice versa affected area clear that, over the plate rail, relies directly its operating compartments (the heart). In particular, the testimonies of the 3rd Engineer Officer and 2nd Engineer Officer, as well as the 2nd Chief Engineer) - combined with audio recordings of communications between the VDR machine and Bridge - have established that in a few minutes (about 3 mins for the EMP and 7 for Diesel Generators Room. aft) the ship has lost Watertight Compartments (WC) nr. 5 and 6 (PEM and then Local DD.GG. aft), while the adjacent WC nr. 4 and 7 (respectively Compressors Galley Room and DG Room), were initially partially flooded, becoming initially dangerous free liquid water surfaces, and then completely filled after about 40 minutes from the contact.

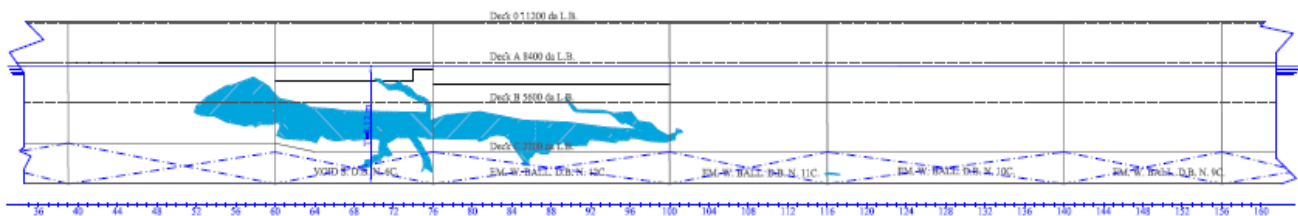
Proiezione sul piano longitudinale della falla principale e di quella minore a cavallo dell'ossatura 116

Where it is represented the longitudinal section involved by the damage upon which the shell plating breaches have been overlapped, according to their accurate assessment.

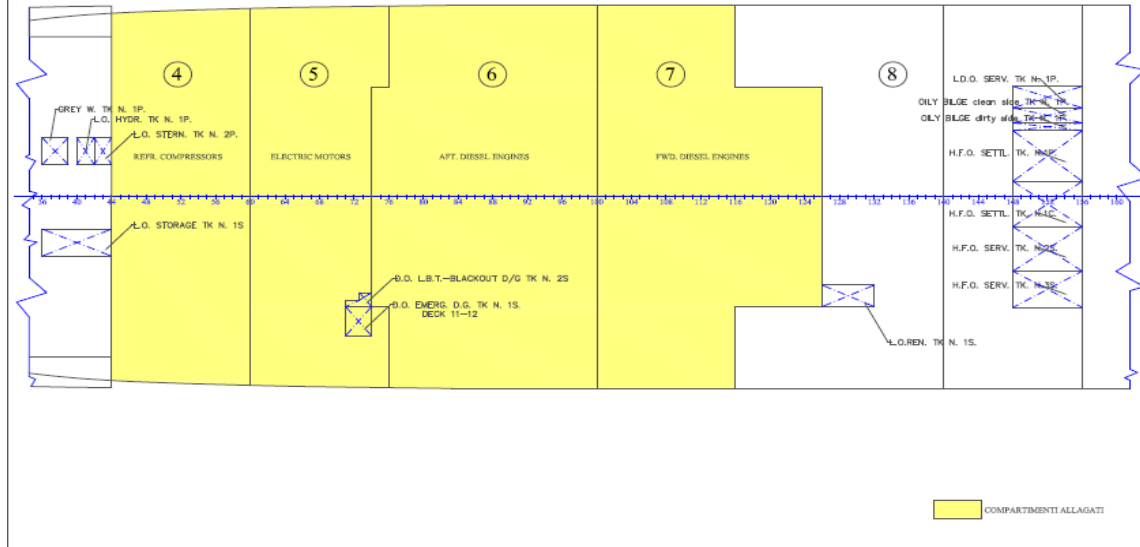
Deck C

Compartimenti allagati al Ponte C

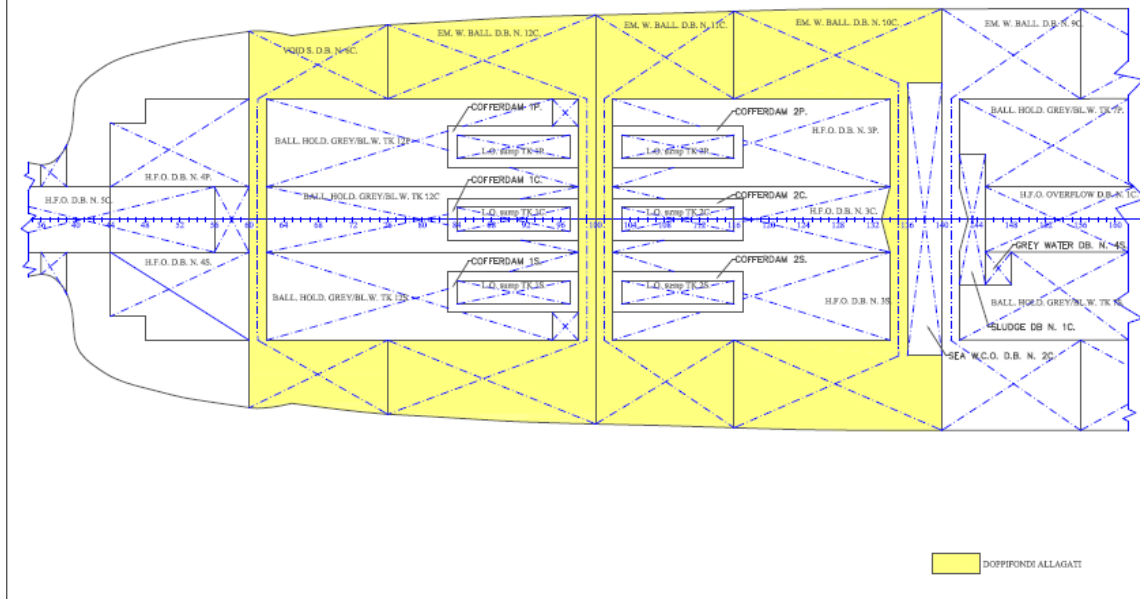
Double bottom

Doppifondi allagati

Here it is possible to view the flooded compartments with their relevant extension from side to side (the central double bottoms have not been involved by the flooding).

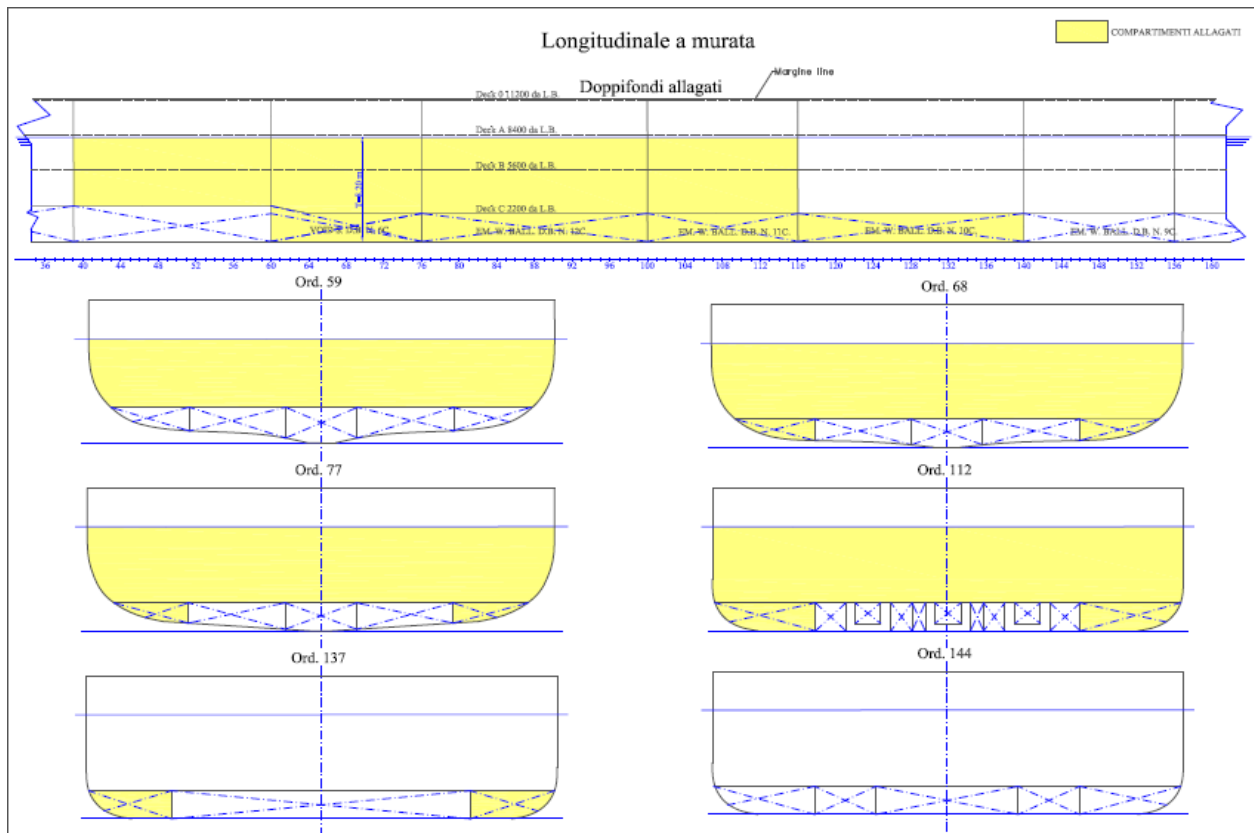
Here in this pictures the yellow parts represent the compartments and side double bottoms immediately flooded from outside at the time of the impact both on the longitudinal plan at side shell and in significant transversal sections too.

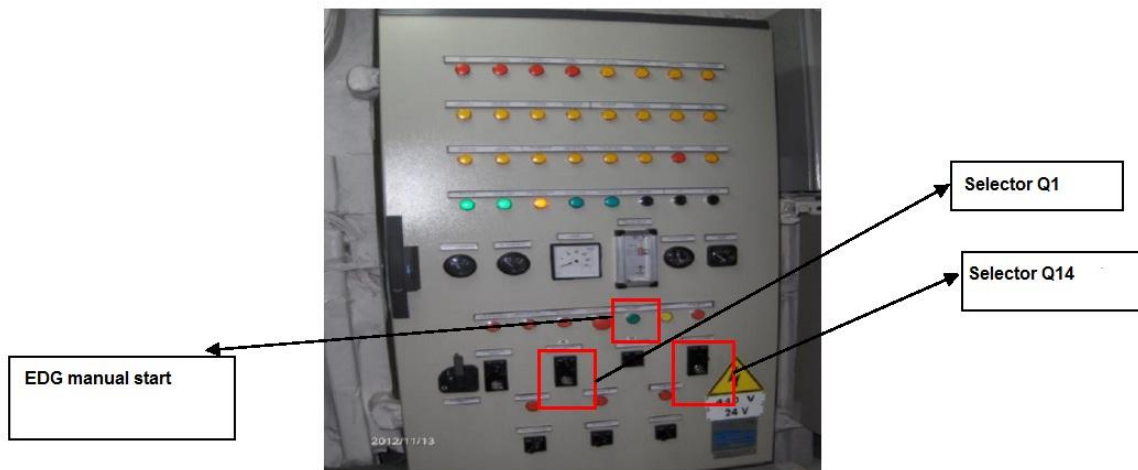
EDG switchboard (Part Number 1Q345063 – item mark XM/277 – sister ship Costa Favolosa)

Isotta Fraschini claims, in other words, that the cause of the suddenly arrest of the related ventilator can be studied and searched only assessing the Concordia Emergency Diesel Generator.

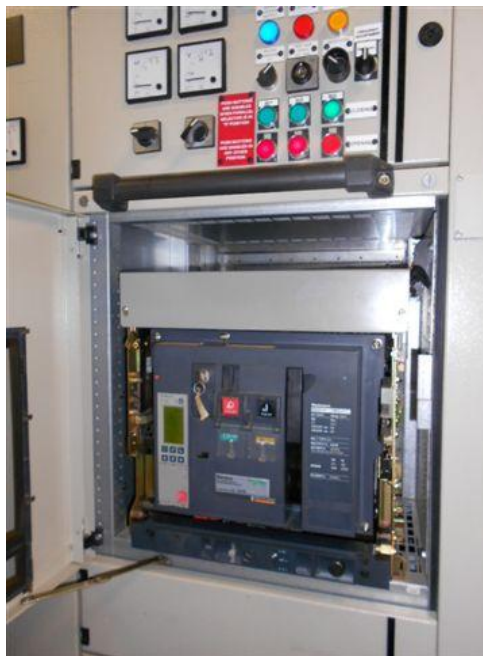
Switch nr. 901 (picture taken from Costa Favolosa)

As per above the concurrency of a short circuit in the lines powered by the ES could be the most reasonable cause of the switch 901 improper functioning.
