Learning after platform supply vessel collision with Statfjord A

Managing Maritime operations through Human
Factors, October 2019

The incident 7 June 2019

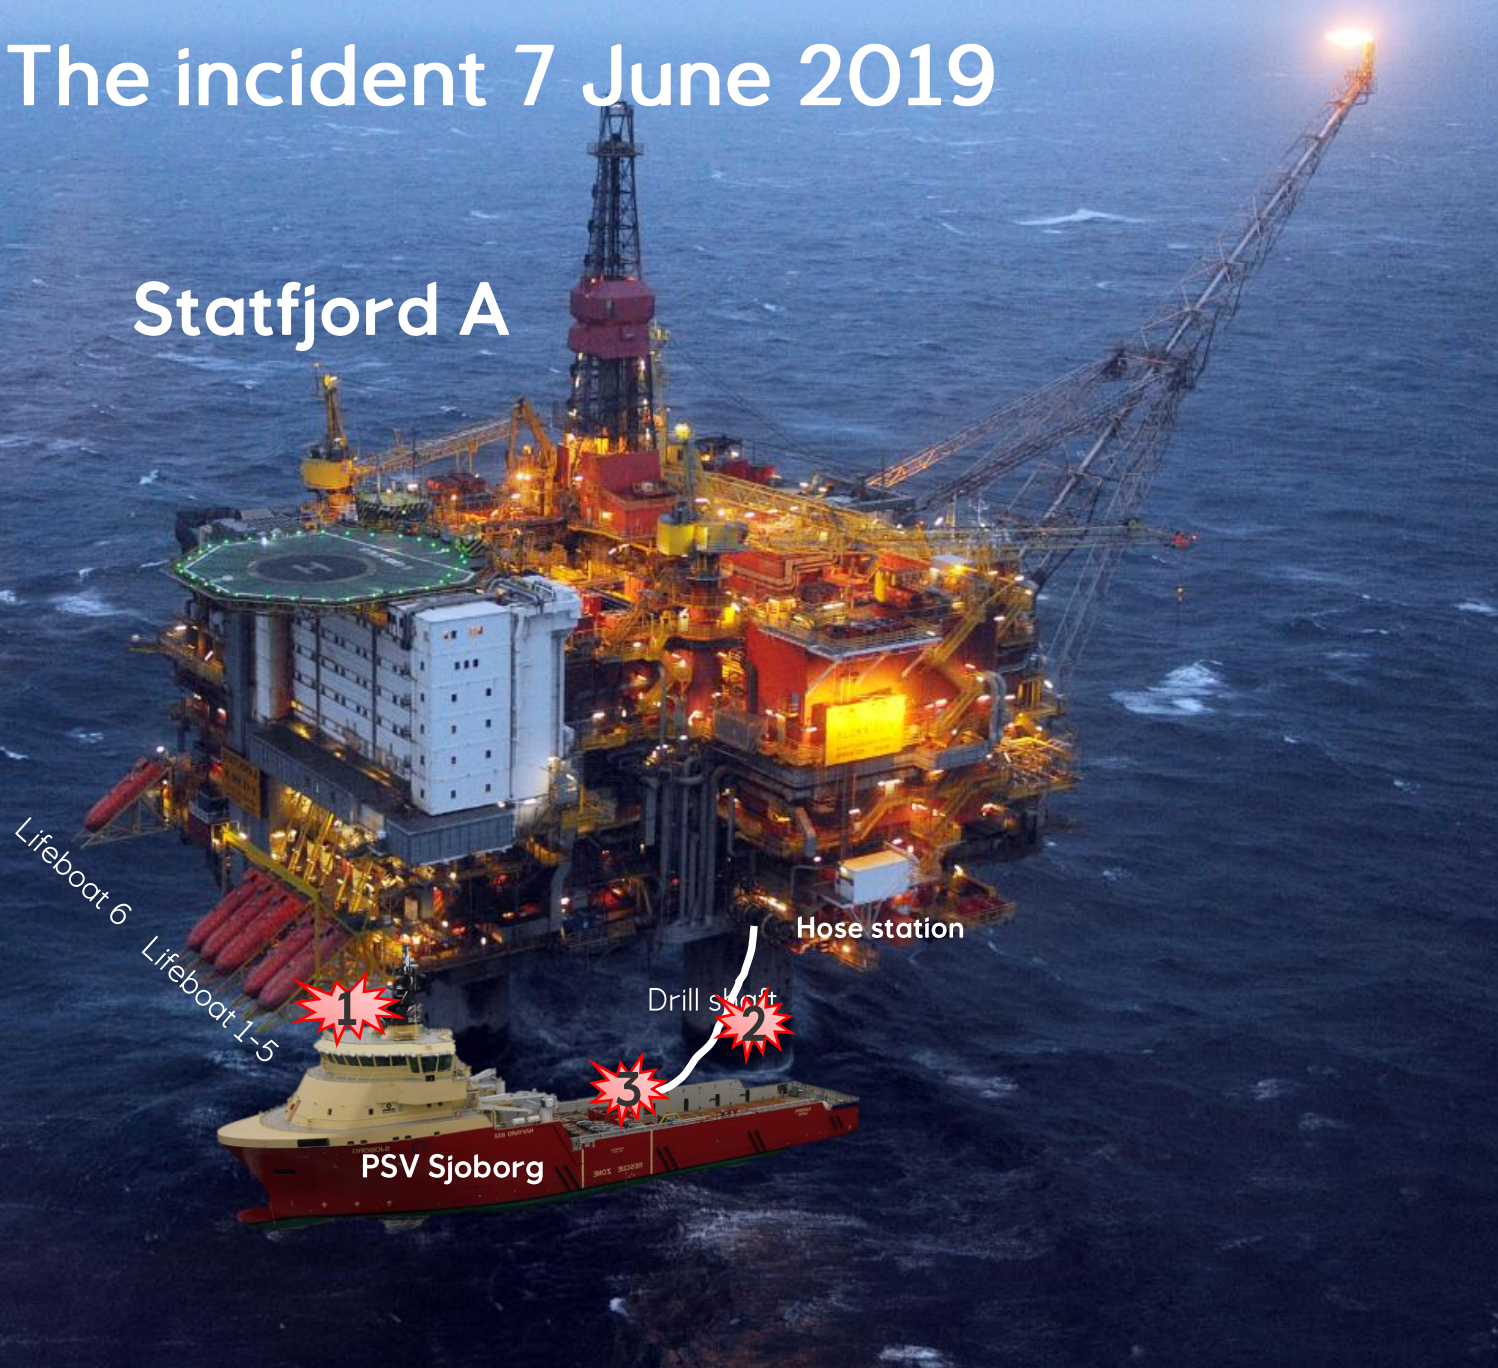
- The weather condition was Beaufort 4-5 from South West
- 01:50 AM the platform supply vessel Sjoborg lost DP-position in connection with a bulk operation at Statfjord A
- PSV Sjoborg subsequently collided SFA's lifeboat structure and drill shaft south
- SFA was in a planned shutdown and had 276 people on board
- PSV Sjoborg had 12 people on board
- Damage to the lifeboat station resulted in evacuation of 218 people by helicopter to surrounding installations in the area
- No persons were injured in connection with the incident, but an able-bodied seaman on PSV Sjoborg was hit by a bulk hose when it went overboard
- An investigation was conducted with the objective to learn such that recurrence can be prevented and to achieve an improvement of the safety level

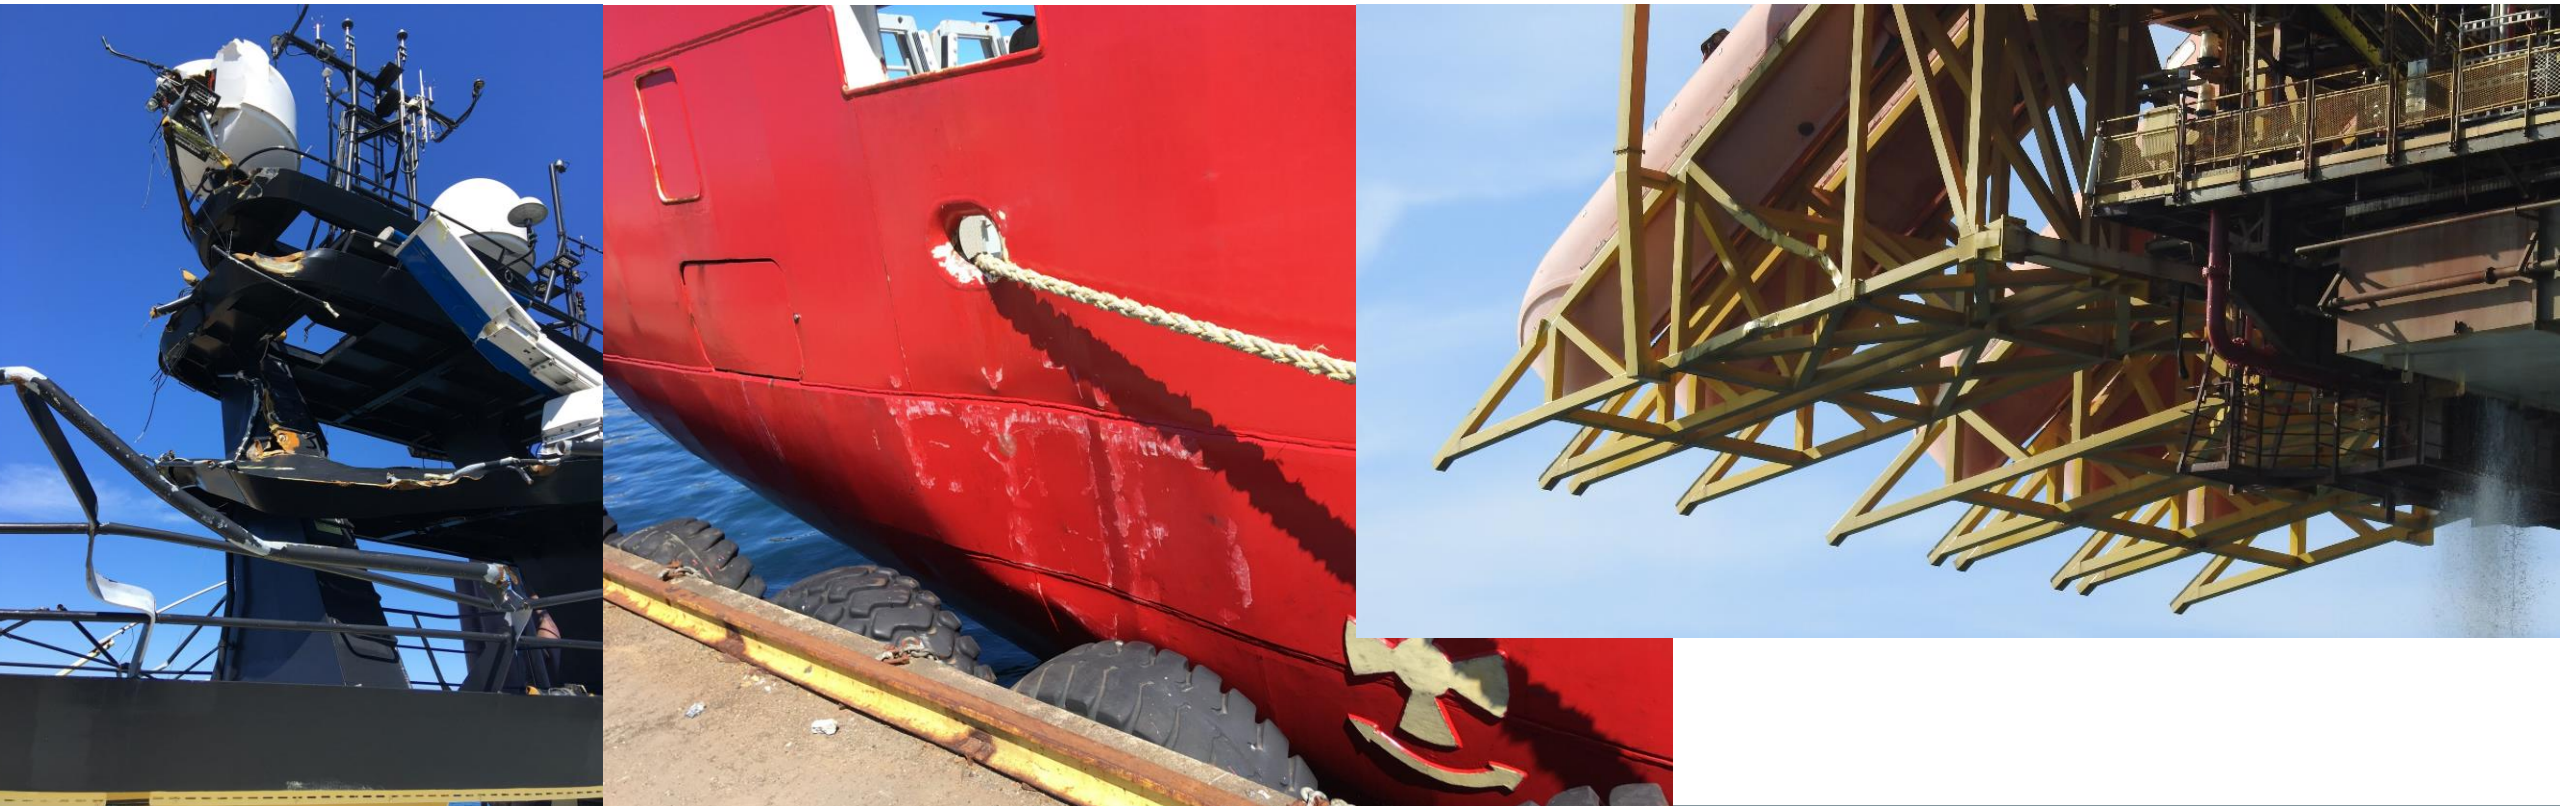
- The incident was classified by highest degree of severity to Red 1 according to Equinor's classification matrix
 - The incident resulted in delayed start of SFA after the planned shutdown
 - If another part of the bulk hose had hit the able-bodied seaman the incident could have been fatal
- The structural integrity of SFA was not impaired by the collision

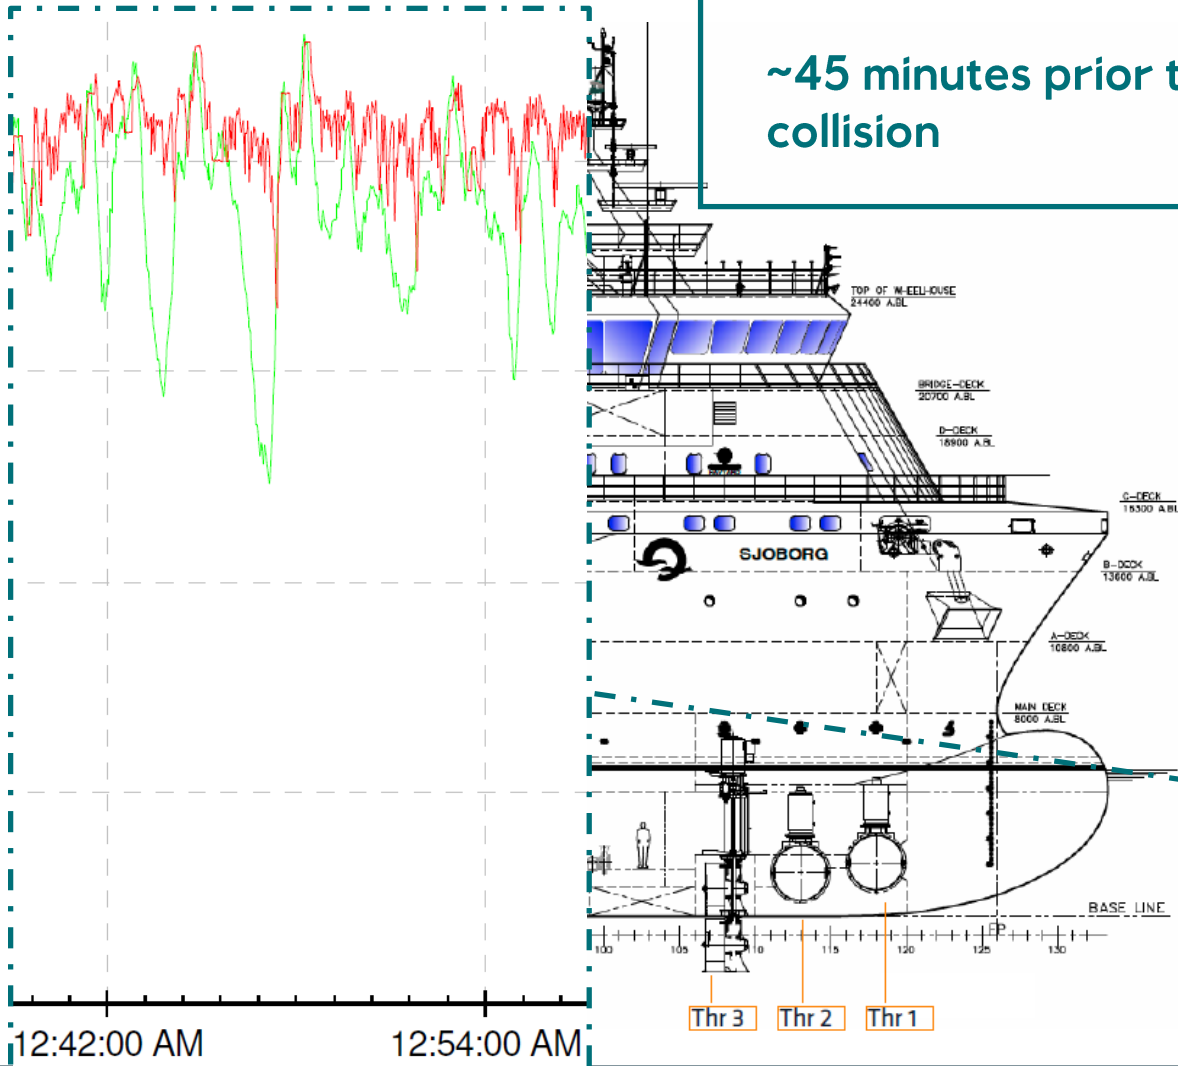
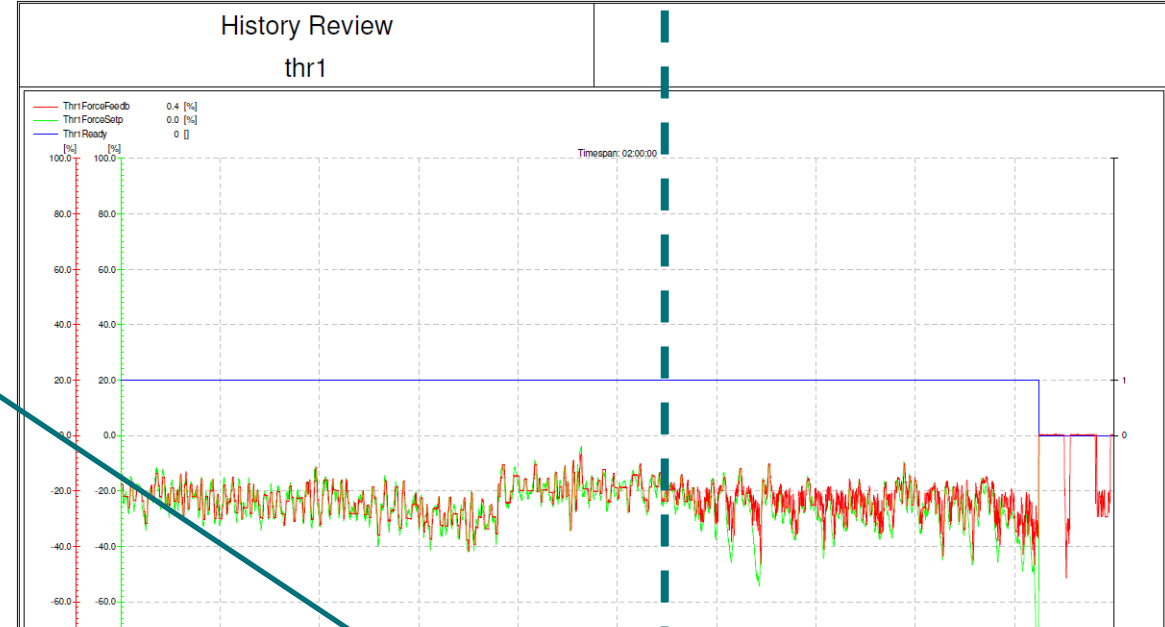
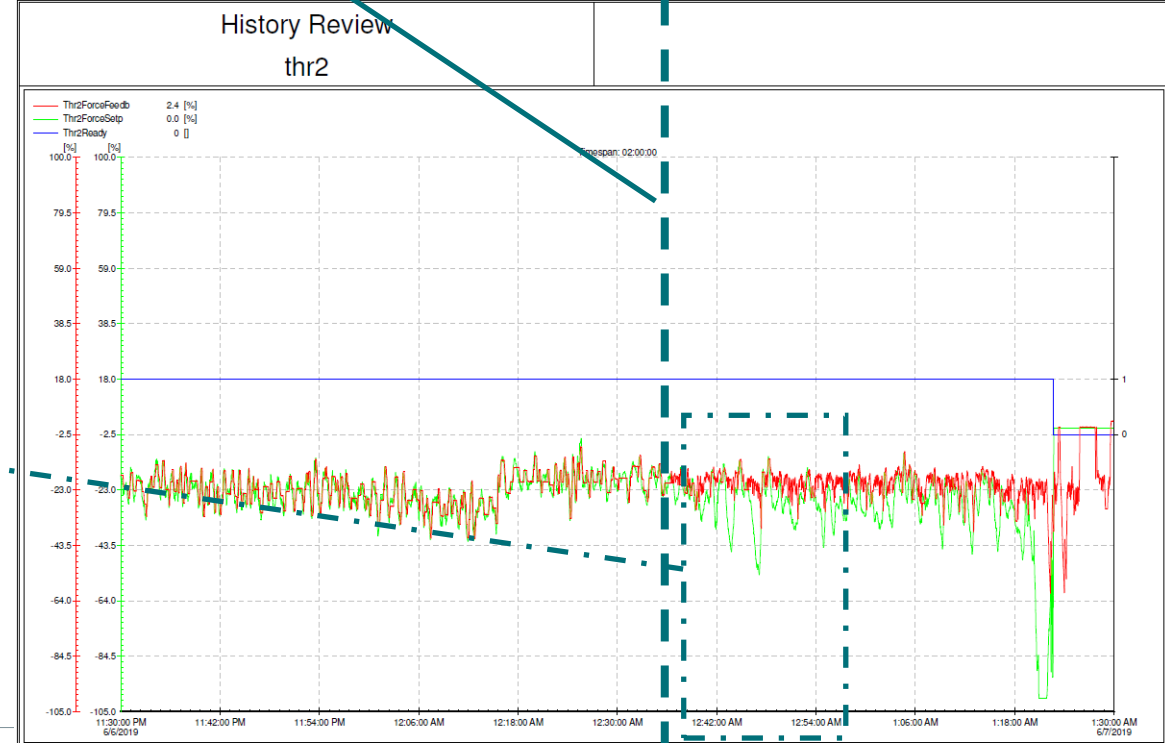
Thrusters' order and feedback

~45 minutes prior to the collision

- The change of character of the thrusters' order and feedback concurred in time with the following general alarms annunciated by the blackout safety system:

- FAULT IN B.O.S.S SYSTEM PS
 - FAULT IN B.O.S.S SYSTEM SB
- Presumably the blackout safety system activated power limit mode for all thrusters around the same time

- The FAULT IN B.O.S.S SYSTEM alarms had been periodically annunciated the last year
- According to the equipment maker the reason for the alarms could be attributed to total harmonic distortion and that this condition was assessed as not critical for the Dynamic Positioning of the PSV Sjoborg

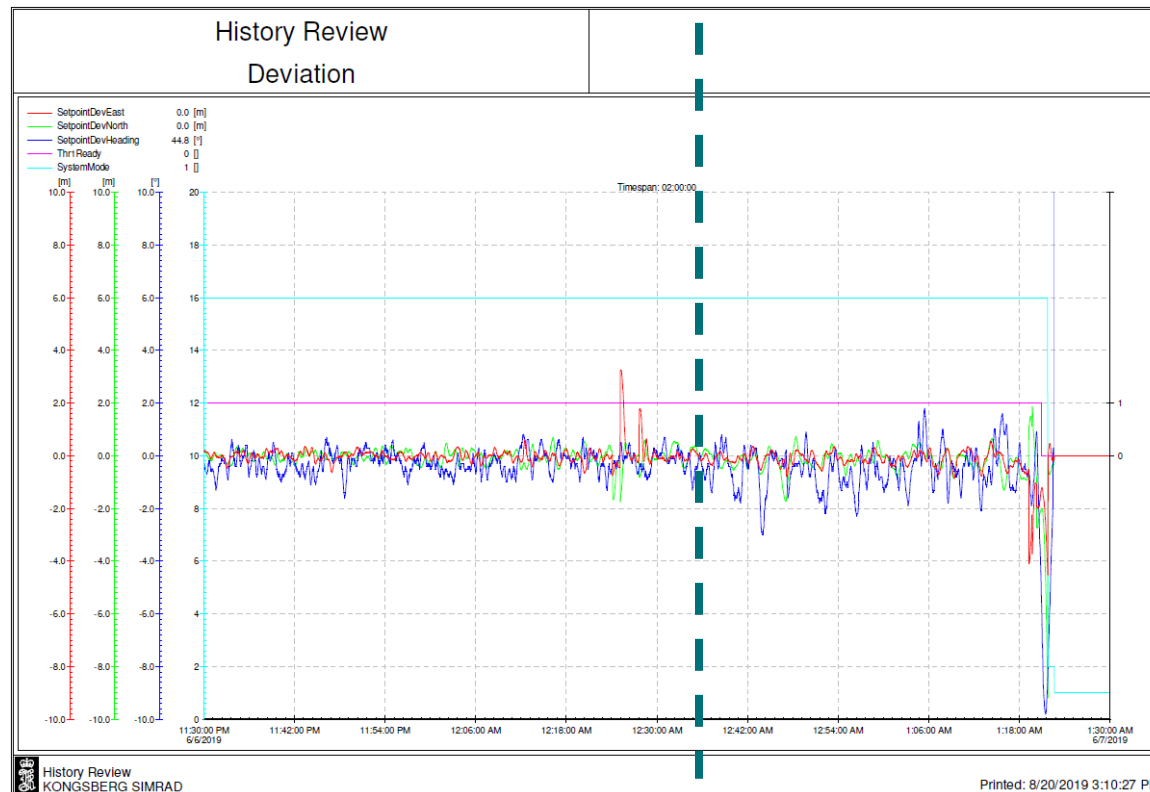
- The change of character of the thrusters' order and feedback had a detrimental effect on the Dynamic Positioning of the PSV Sjoborg particularly for heading

- HEADING OUT OF LIMITS warnings or alarms are reported if the deviation between wanted and actual heading exceeds the operator specified alarm point
- Some important DP alarms and warnings were (the time stamps are approximate to Norwegian local time):

Time	Message	Additional info.
01:14:00	Heading out of limits	3.0 3.0
01:16:50	Tunnel bow 2 prediction error force	-23.0 -50.5
01:45:58	Azimuth aft STBD prediction error RPM	57.1 85.9
01:50:06	Azimuth aft STBD prediction error RPM	57.0 84.9
01:50:18	Azimuth aft STBD prediction error RPM	57.0 84.9
01:50:34	Tunnel bow 2 prediction error force	-21.1 -49.1
01:50:36	Azimuth bow 3 prediction error force	30.1 70.0
01:50:44	Heading out of limits	3.3 3.0
01:50:44	Azimuth aft PORT prediction error RPM	59.5 100.0
01:50:53	Tunnel bow 1 high force	80
01:50:53	Tunnel bow 2 high force	80
01:50:53	Azimuth bow 3 high force	80
01:50:54	Tunnel bow 1 not ready	
01:50:57	Azimuth aft STBD prediction error RPM	57.0 84.9
01:50:57	Heading out of limits	5.5 5.0
01:50:58	Azimuth bow 3 not ready	
01:51:09	Tunnel bow 1 prediction error force	-25.4 -71.2
01:52:07	Heading out of limits	3.3 3.0
