ELEGANCy

## Mt. Terri experiment: fault trapping

## Objectives of the CS-D experiment:

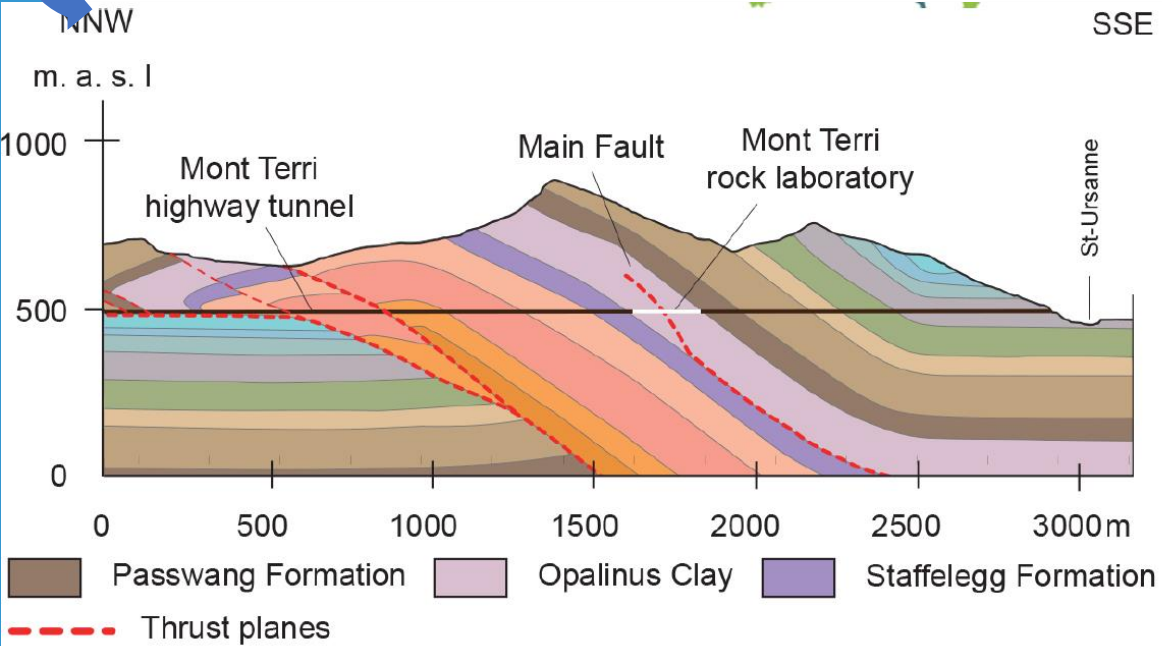
After Nussbaum et al. (2017): Tectonic evolution around the Mont Terri rock laboratory, northwestern Swiss Jura: constraints from kinematic forward modelling. *Swiss Journal of Geosc.*, 110, DOI 10.1007/s00015-016-0248-x.

**Flow through faults, potential leaks through a cap rock:**

Simulating CO<sub>2</sub> (dissolved in formation water) leaking through a fault in a caprock

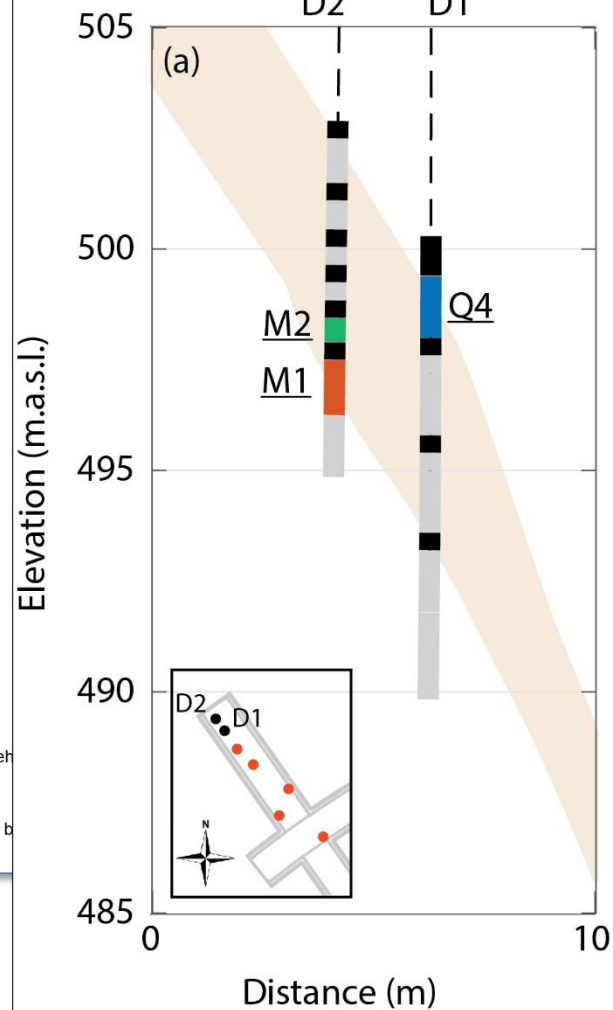
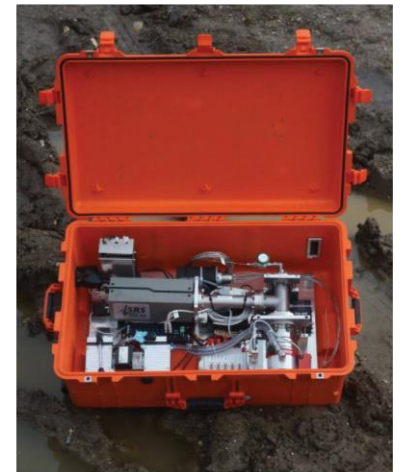
(d) Monitoring borehole D2 and Injection borehole D1

Intervals:

- Injection - Q4
- Pressure and pH - M1
- Dissolved gases - M2
- Packers
- Spacers
- Fault zone

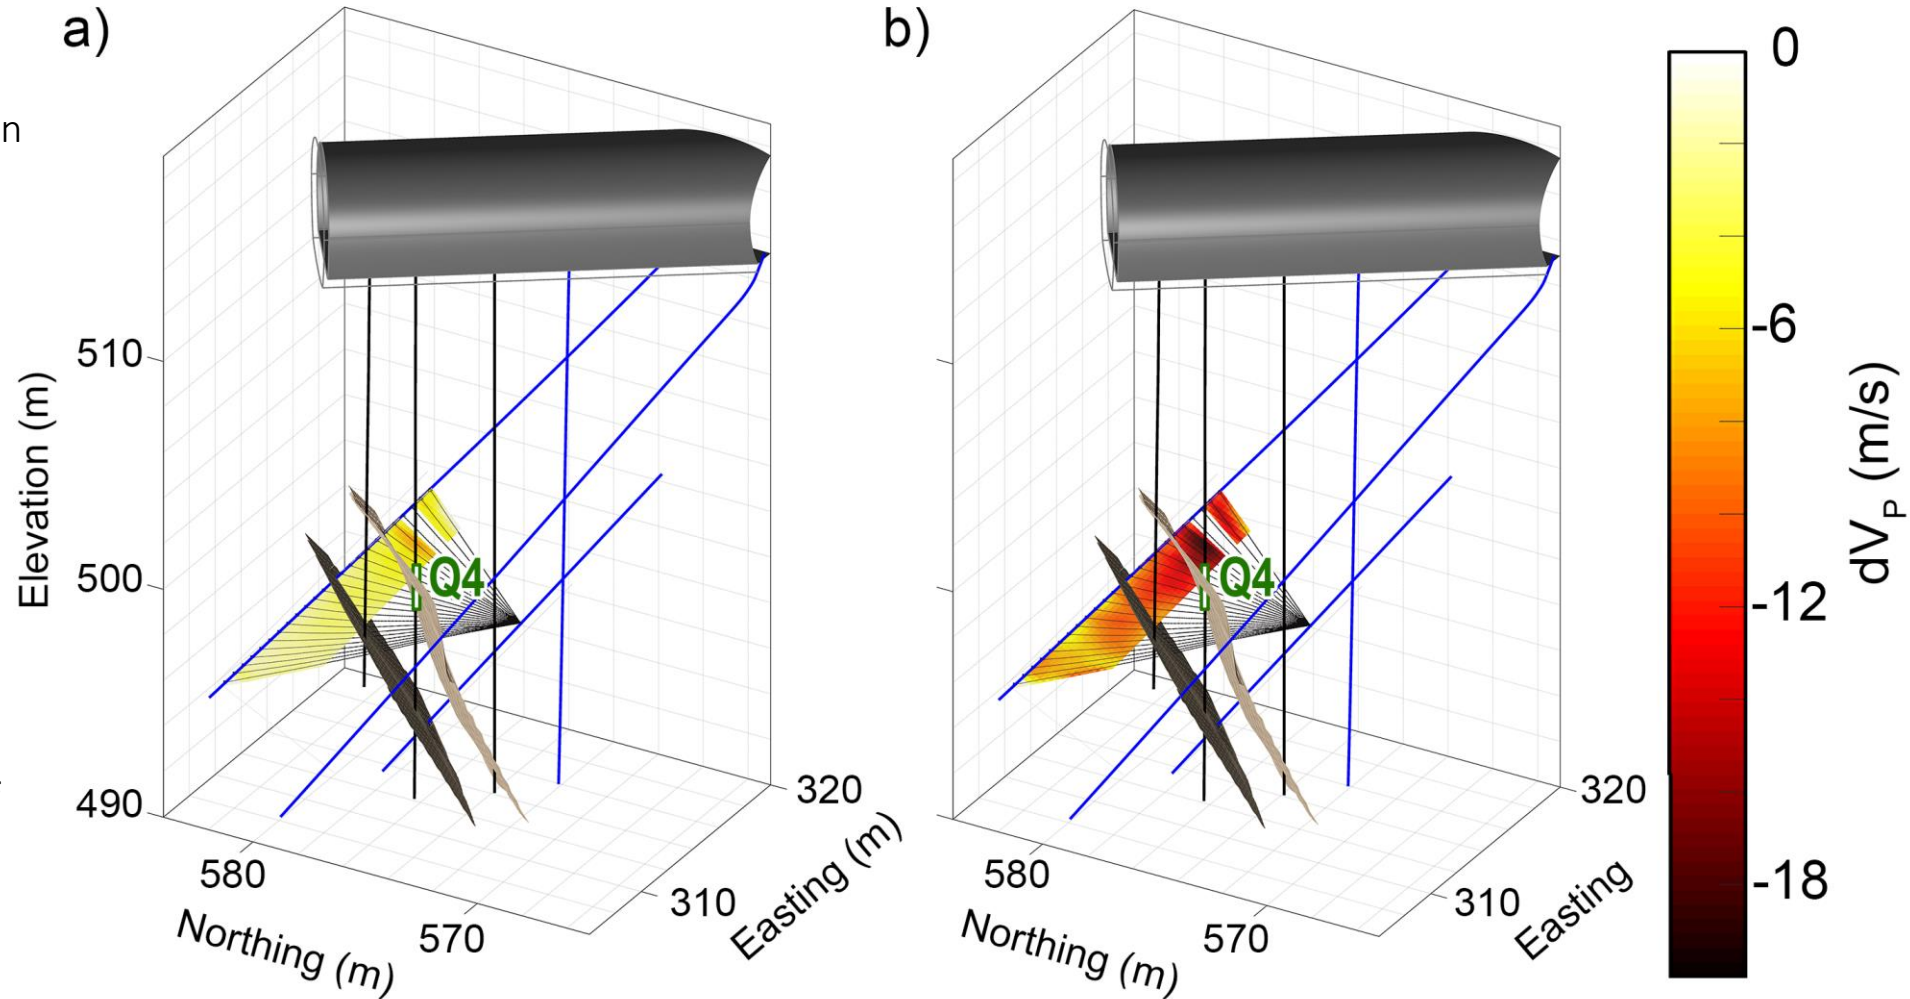
## Active Seismic monitoring

- P-wave sparker shots repeated after each injection step-up
- Change in P-wave velocity ( $dV_p$ ), relative to  $V_p$  from baseline tomogram
- Figure a:  $dV_p$  at injection pressure of 2.4 MPa (first step)
- Figure b:  $dV_p$  at injection pressure of 4.5 MPa (last step)
- Reduction of  $V_p$  by around 1% in the vicinity of the injection interval

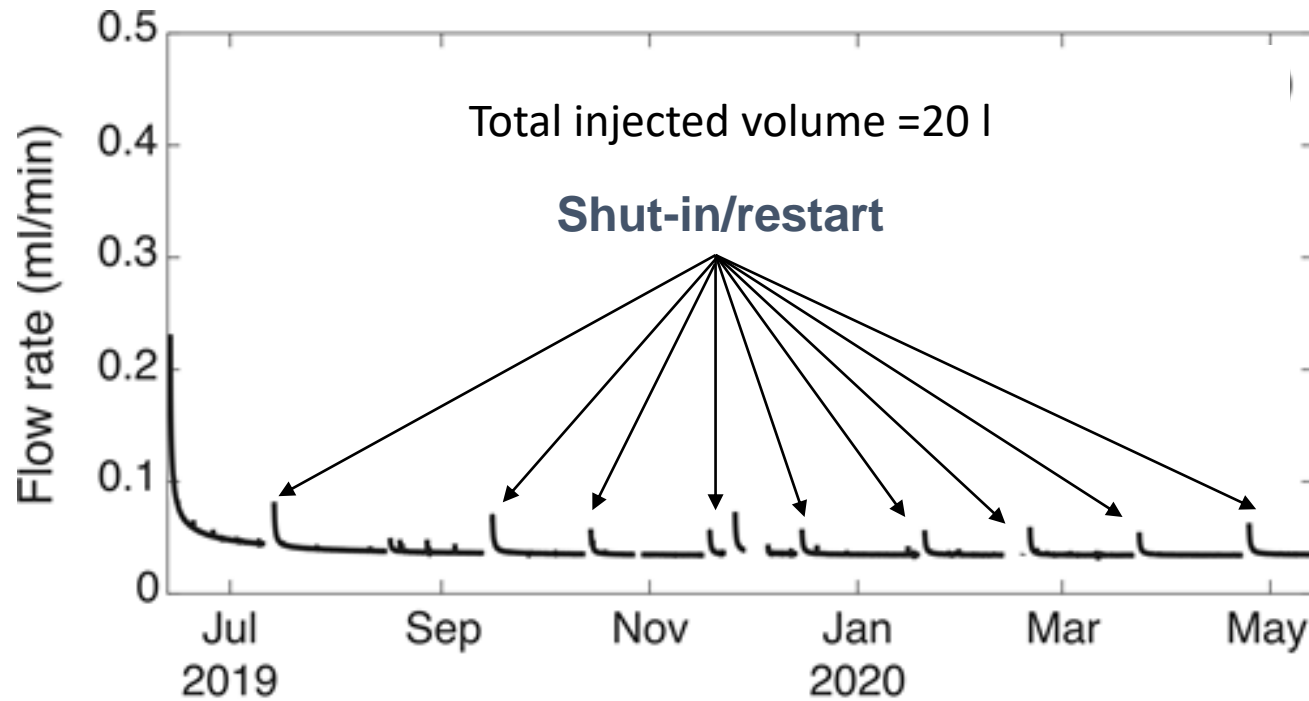
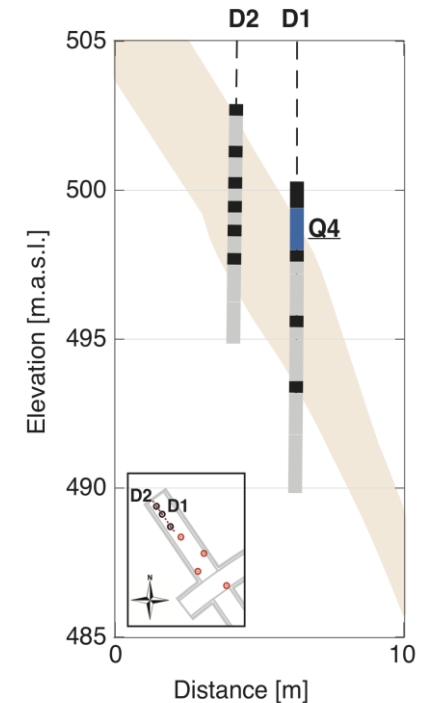
- **Phase 2:** injection at 4.5 MPa, syn. water+Kr+CO<sub>2</sub> (mixed at about 2.2 MPa)

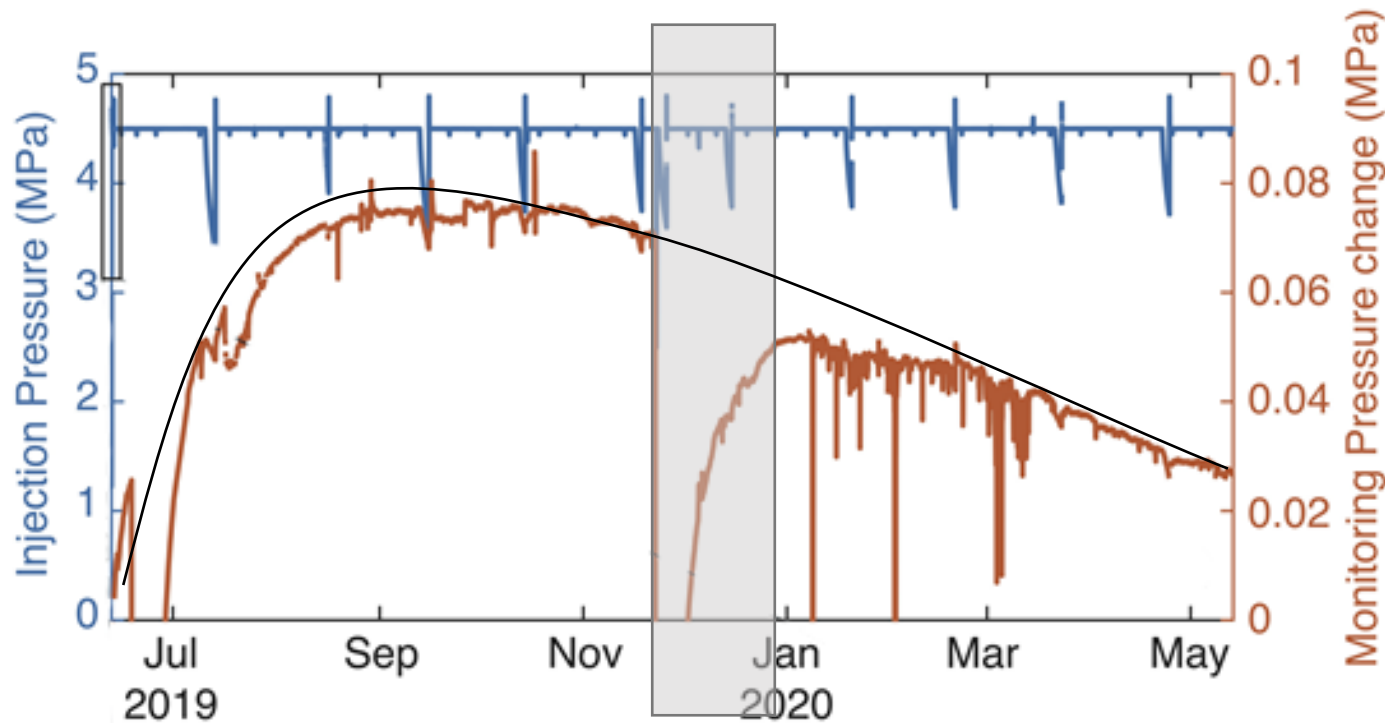
- **Phase 2:** injection at 4.5 MPa, syn. water+Kr+CO<sub>2</sub> (mixed at about 2.2 MPa)

Pressure at monitor first increased then decreased after plateau  
Could it be fault/fracture self-sealing? Swelling?

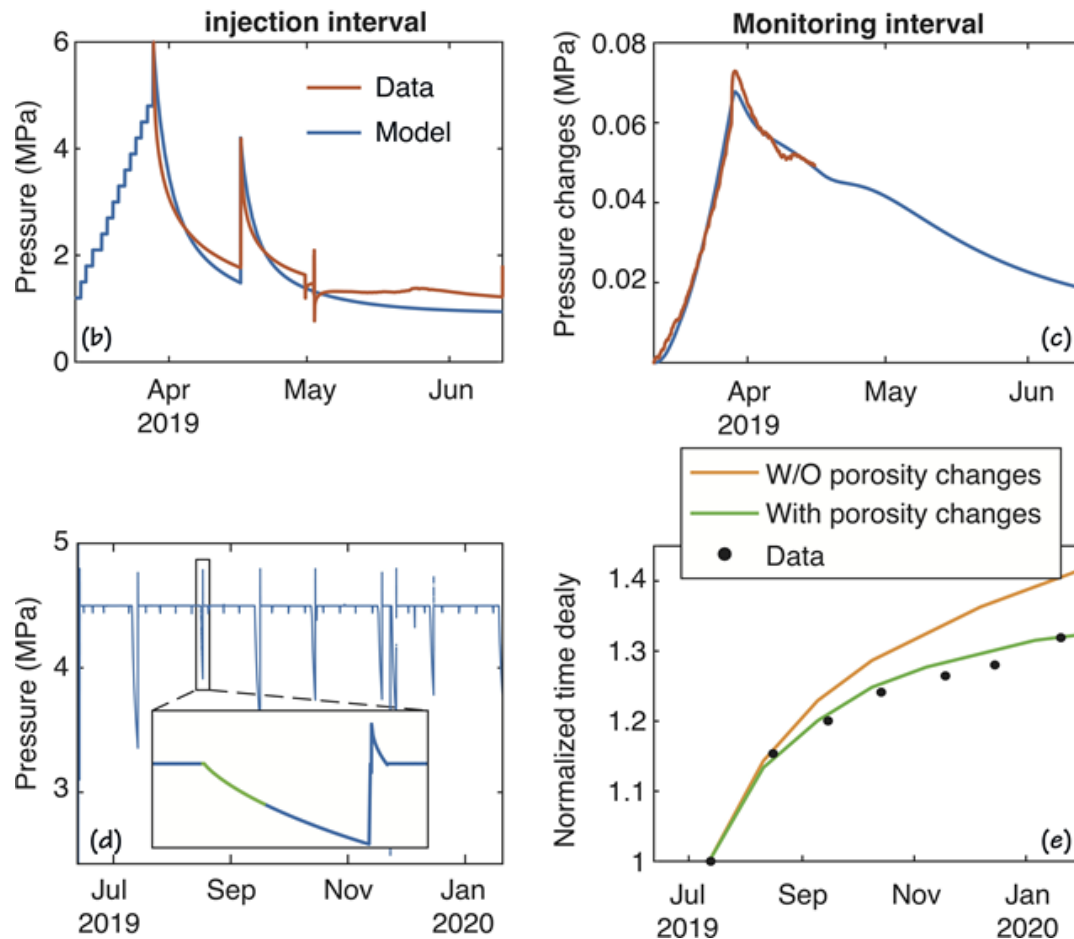
- **Modeling:** iTOUGH2 ; inverse modeling by accounting for the pressure recorded during one week long injection test

The behaviour at the monitoring point is captured when assuming the fracture not directly connected to the near well region, and allowing for closure (lower permeability) during shut-in (c). The trend in (e) better agrees with a model where the porosity decreases in the vicinity through time of the injection interval (green line in Fig. 4e, with a fix 0.5% decrease at each step) compared to a model with no porosity changes (orange line).<sup>10</sup>

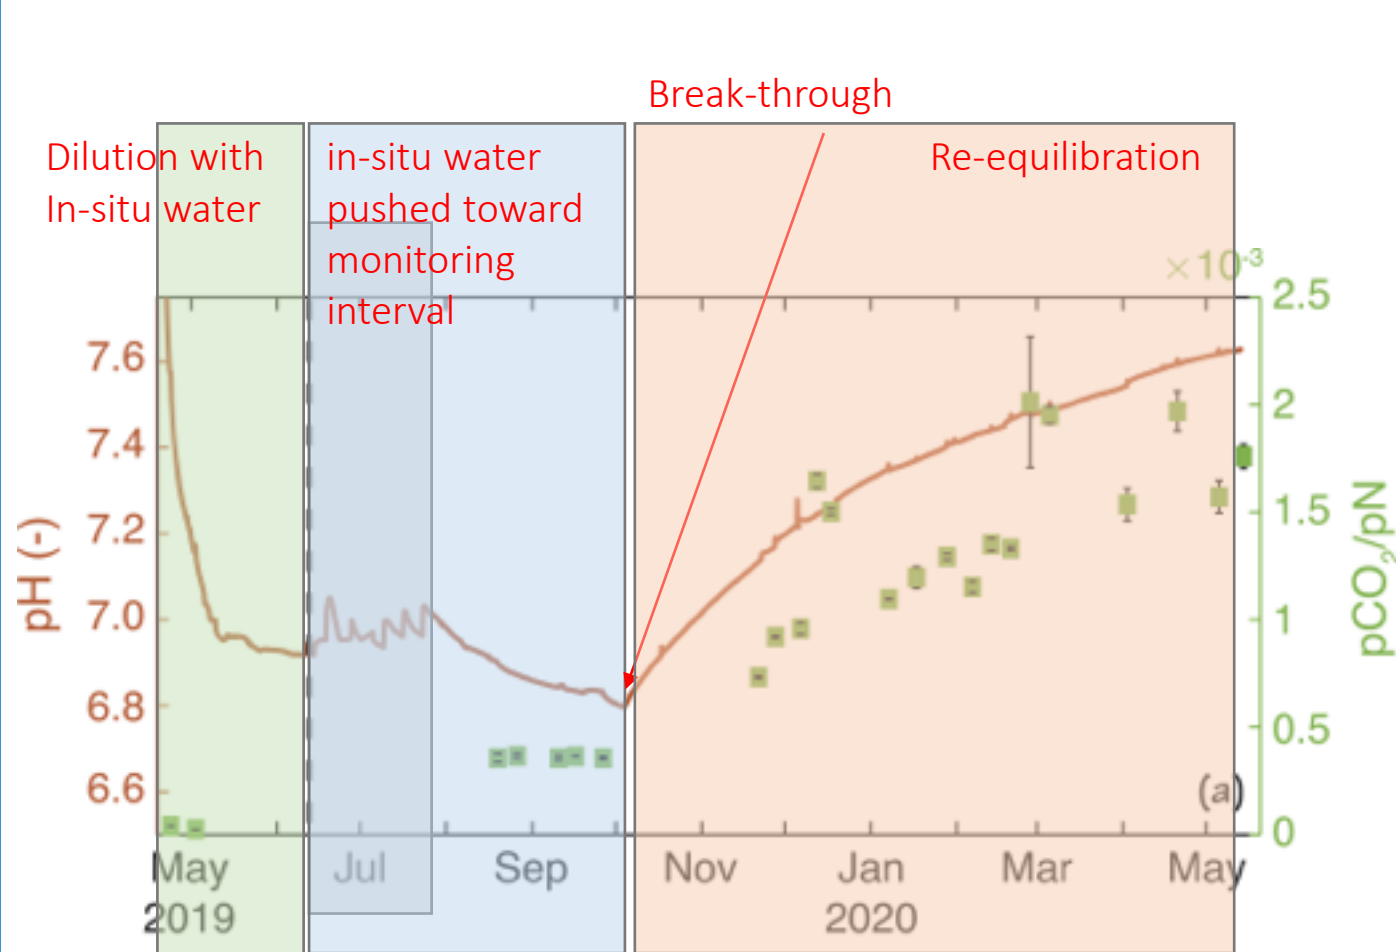
pH synt. water in D2=7.8  
pH injected water (syn+CO<sub>2</sub>)=5.5
