THE KJØRBO INCIDENT

CEO, Nel ASA

Press conference
June 28, 2019

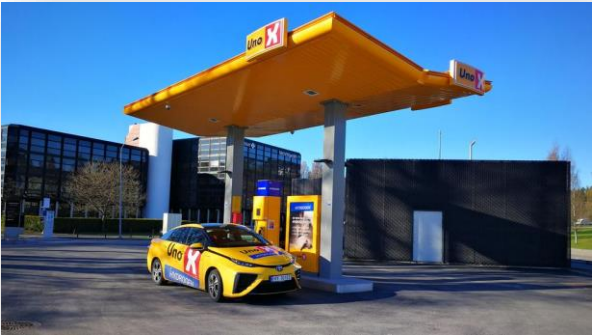
The Kjørbo site

- Opened 2016
- Owned by Uno-X Hydrogen
 - JV between Uno-X, Nel, and Nippon Gases (formerly Praxair)
- Nel H2Station® with on-site hydrogen production from electrolysis
 - Product family: CAR-200 Europe

Drawing for illustrative purposes only. Not to scale.

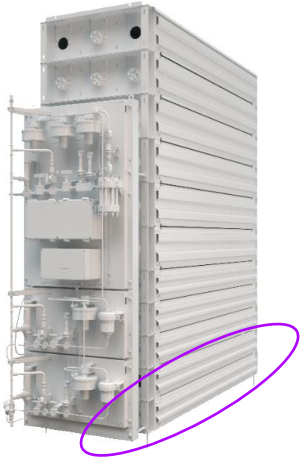
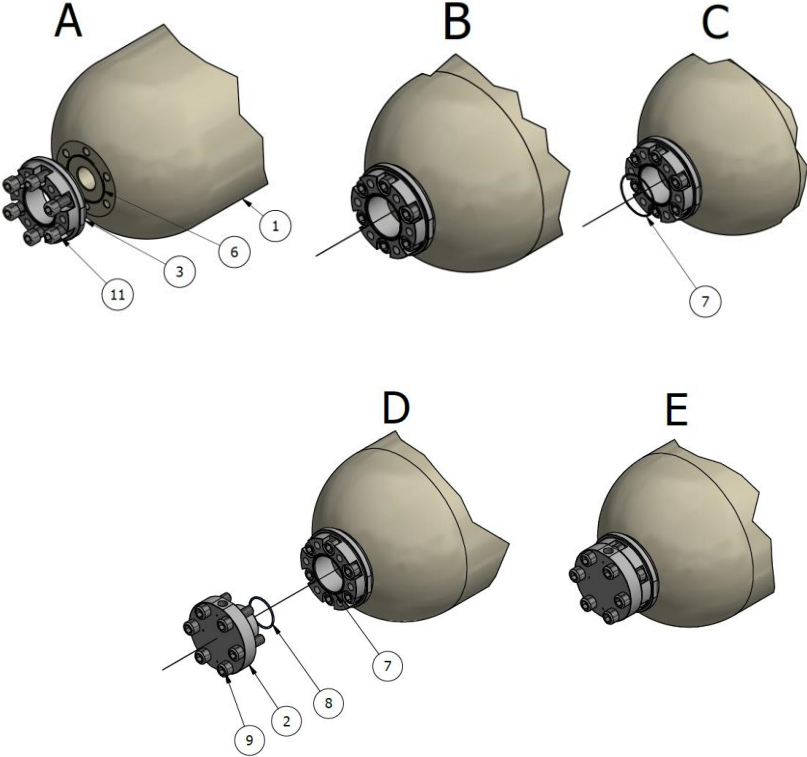
Root cause

- Assembly error in high-pressure storage unit
- Unit consists of steel tanks and other components by third parties, some of which are designed by Nel
