Severe Accident in Fukushima Dai-ichi Nuclear Power Plant and Lessons-Learned

October 14th , 2015

Akira Yamaguchi
University of Tokyo, JAPAN
E-mail: yamaguchi@n.t.u-tokyo.ac.jp

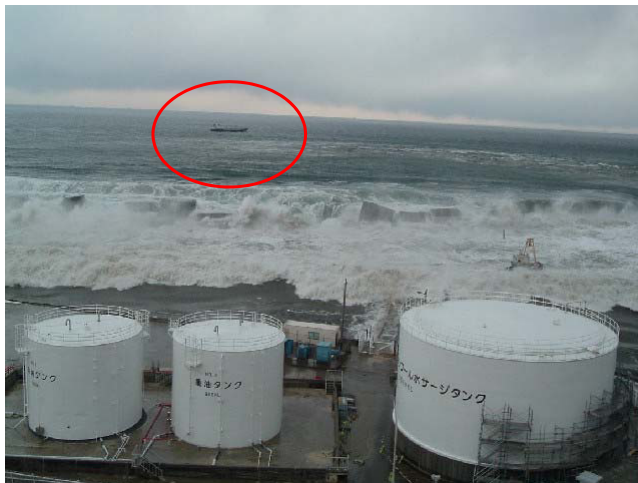
Crew decision: A tanker feeding heavy oil at the port escaped narrowly in emergency

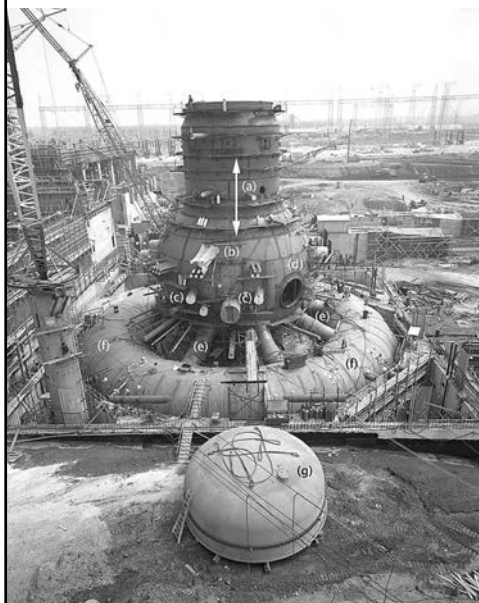
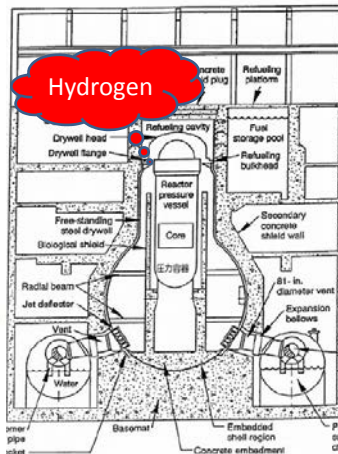
Boiling Water Reactor Mk-I Type (Browns Ferry)

- Core location (a)
- Penetrations for control rod hydraulics (b)
- Steam and feedwater lines (c)
- Access door (d)
- Pressure balance tubes (e)
- Suppression pool (f)
- Pressure vessel dome (g)

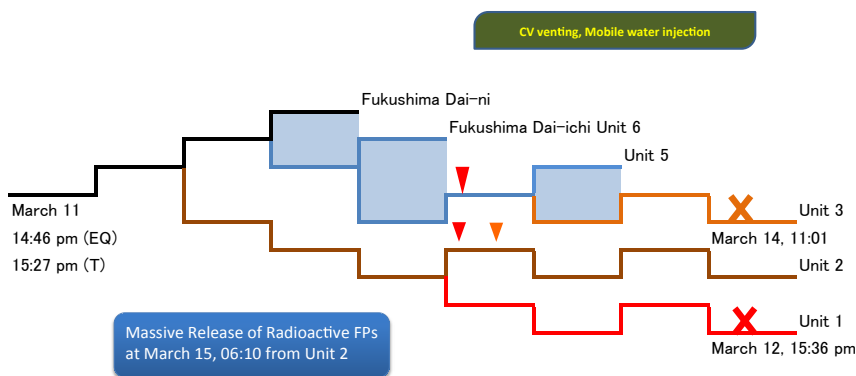
Accident Progression at Fukushima #1 and #2 Sites

Earthq. Tsunami	Reactor Scram	DC Power	Off-site Power	EDG	High Press. Cooling	AC Power Recovery	Reactor Depress.	Residual Heat Removal
-----------------	---------------	----------	----------------	-----	---------------------	-------------------	------------------	-----------------------
