B737 MAX: Lessons Learned from Tragedy

Katherine Wilson, PhD
National Transportation Safety Board
Washington, DC

Lion Air Flight 610

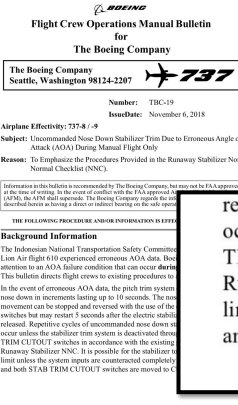
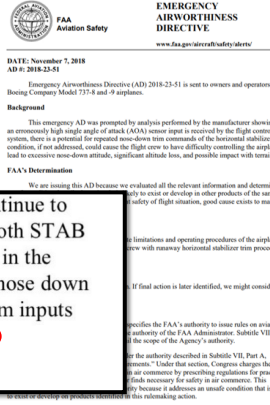
released. Repetitive cycles of uncommanded nose down stabilizer continue to occur unless the stabilizer trim system is deactivated through use of both STAB TRIM CUTOUT switches in accordance with the existing procedures in the Runway Stabilizer NNC. It is possible for the stabilizer to reach the nose down limit unless the system inputs are counteracted completely by pilot trim inputs and both STAB TRIM CUTOUT switches are moved to CUTOUT.

Emergency guidance released

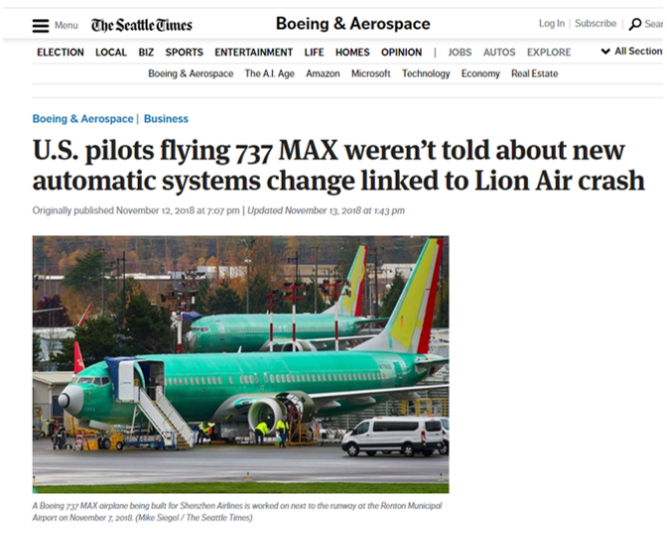
No mention of new "automatic system" in pilot or aircraft manuals

U.S. pilots flying 737 MAX weren't told about new automatic systems change linked to Lion Air crash

Pilots for two U.S. airlines flying Boeing's 737 MAX weren't trained about a key change to an automatic system that's been linked to the fatal crash of a Lion Air jet last month, according to pilot representatives at both
