Marine Casualties Investigative Body

COSTA CONCORDIA

Marine casualty on January 13, 2012

Report on the safety technical investigation

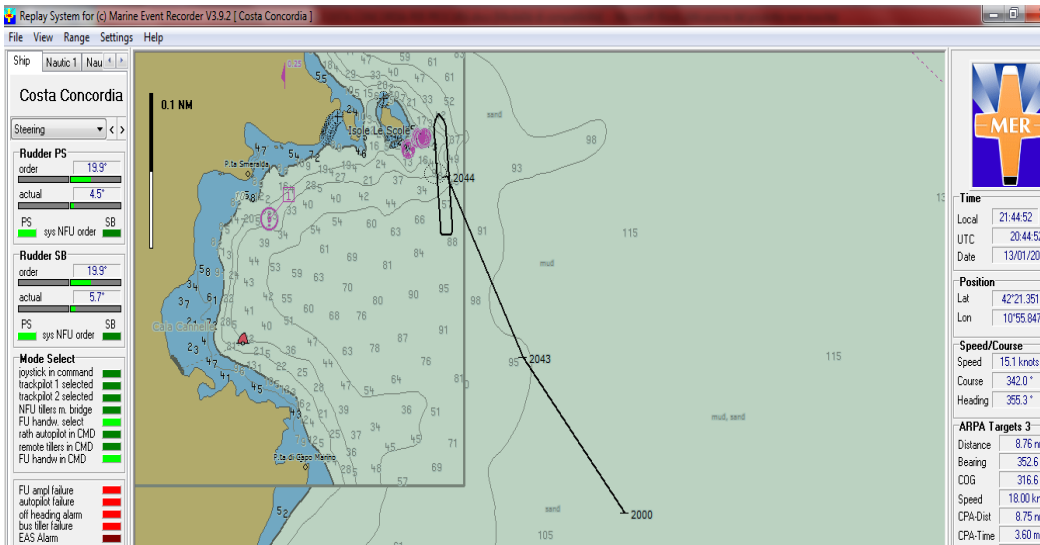
The helmsman , on the contrary, it performs 20 degrees to starboard rudder and the rudder therefore not "continuing" its course, as it should according to the intentions of The Master to the left, but returned again to starboard. In fact, the rudder left up to 4.5 degrees to starboard actual (first 2 degrees to starboard) and 5.7 degrees to starboard to starboard (before 3.9 degrees to starboard).

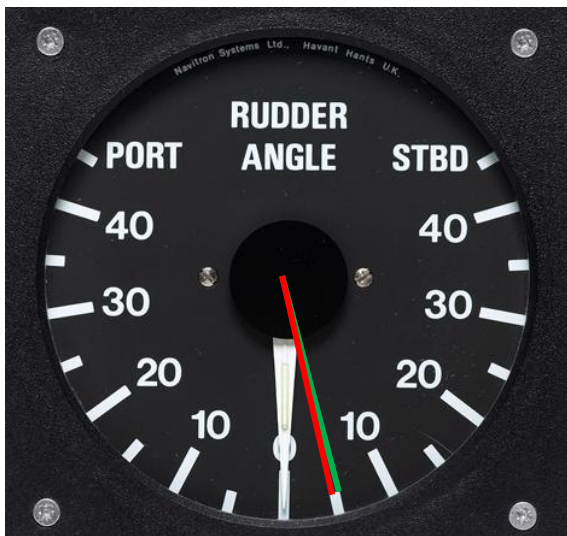
The helmsman realizes the error and corrects it by bringing the left rudder (spend about 8 seconds from the moment when the helmsman maneuver from 20 degrees to starboard at 20 degrees to the left) but the effect on the rudder given by the previous maneuvers carried determines a further shift to the left toward the starboard side and a slight movement to the left of the starboard. In fact, the rudder left up to 5.4 degrees to starboard actual (before 4.5 degrees to starboard) and 5.5 degrees to starboard to starboard (before 5.7 degrees to starboard).

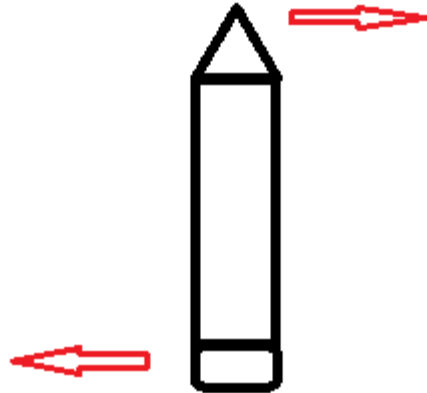
The manoeuvre, requested by the Master and properly carried out by The helmsman first error highlighted, determined the placement of all the helm to starboard, with a consequent marked movement of the bow to starboard and stern to the left, then to the ground.

Orders progressive left (up to "hard left") were probably given with the intention to "stop" the rotation of the earth towards the stern.

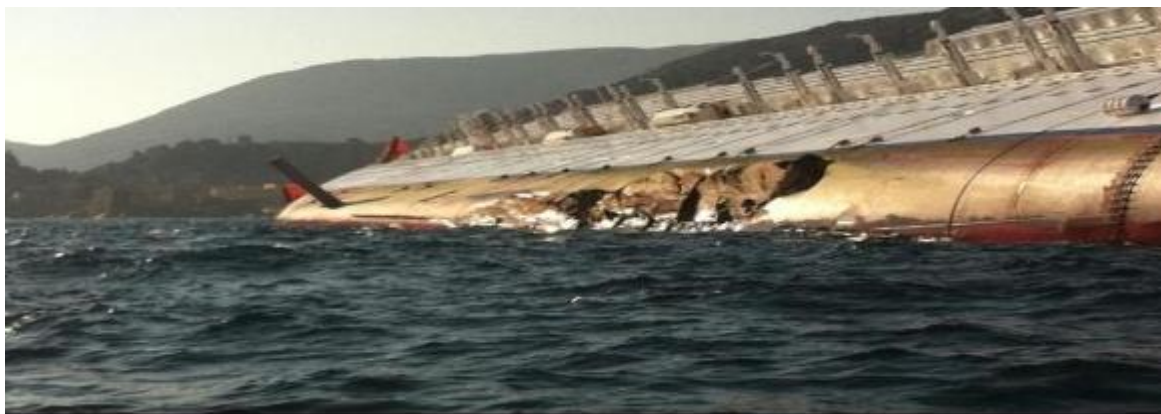
The water appears to have also affected the adjacent WC nr. 3 and 8 (respectively Local Stores and Local Evaporators), which consists of more than free liquid surfaces, hazardous for the purposes of further reduction of the dynamic stability.
