Learning after platform supply vessel collision with Statfjord A

Managing Maritime operations through Human
Factors, October 2019

The incident 7 June 2019

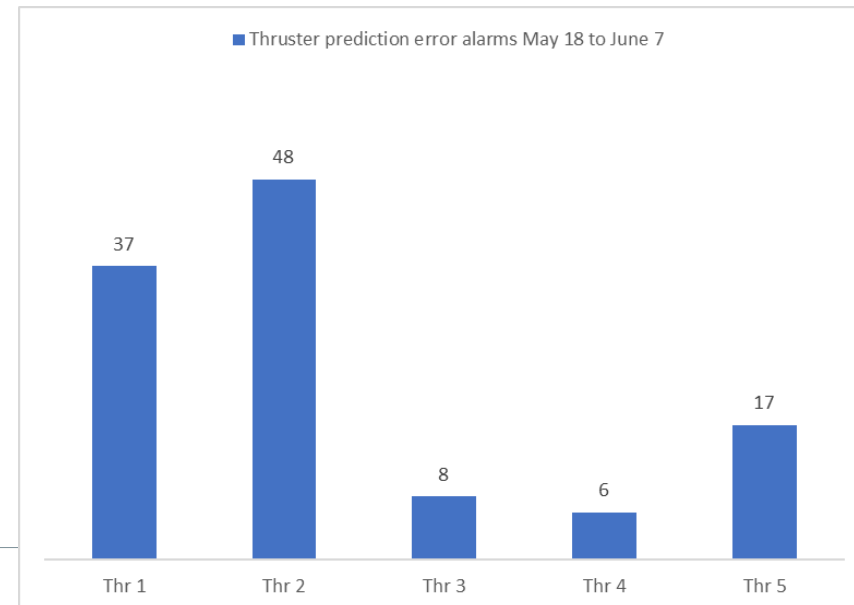
Multiple alarms with unclear possible consequence – the background

- The change of character of the thrusters' order and feedback concurred in time with the following general alarms annunciated by the blackout safety system:

- FAULT IN B.O.S.S SYSTEM PS
 - FAULT IN B.O.S.S SYSTEM SB
- Presumably the blackout safety system activated power limit mode for all thrusters around the same time

- The FAULT IN B.O.S.S SYSTEM alarms had been periodically annunciated the last year
- According to the equipment maker the reason for the alarms could be attributed to total harmonic distortion and that this condition was assessed as not critical for the Dynamic Positioning of the PSV Sjoborg

- THRUSTER/RUDDER [#] PREDICTION ERROR alarms are reported if the order and feedback of a thruster do not agree (alarm points specified by the equipment maker)

- In the period from May 18 to June 7 there were in total 116 prediction error alarms annunciated by the DP-system on PSV Sjoborg
- As these alarms had no apparent detriment to the Dynamic Positioning of the PSV Sjoborg they were assessed as not critical
